# Technical Service Bulletin

| <b>Technical Service Bulletin:</b> TSB210118 | <b>Released Date:</b> 07-Jun-2021 |
| <b>Excessive Oil Carryover - Rocker Lever Cover Port Restriction</b> | |

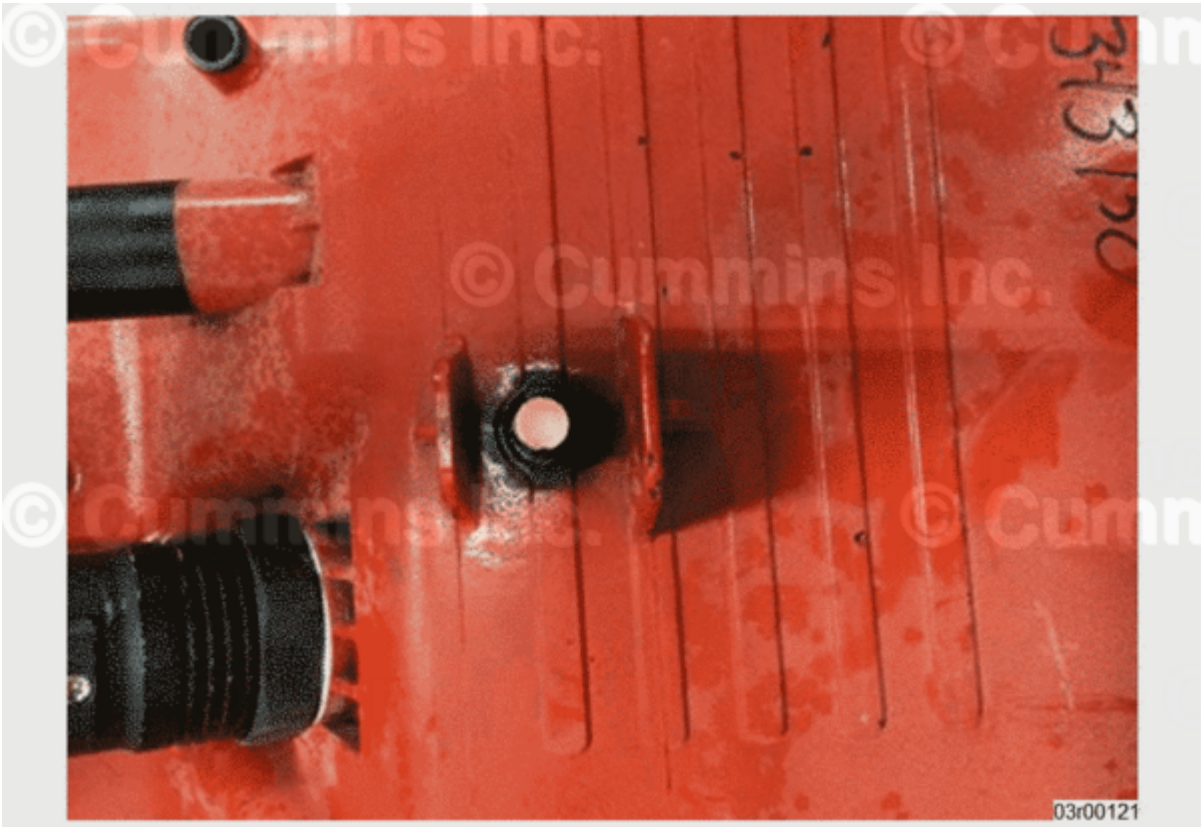
- The rocker lever cover connection port for the crankcase breather air supply line and the air supply to the oil separator jet pump is restricted.

- Inspect the rocker lever cover connection point for the crankcase breather tube and check to see if there is a restriction.

Figure 1, Free Flowing Rocker Lever Cover Connection Port.

- If the rocker lever cover connection port is restricted, punch out the remaining material in the port. This material can fall into the oil separator cavity and stay there for the life of the engine with no adverse effects.
