# AfterSales Diagnostic Sheet

**MAS002747**  
(BOL 21-21)

## HALF (HAPTIC Lane Feedback) – Anomalies

**Model:** M156/M157/M161

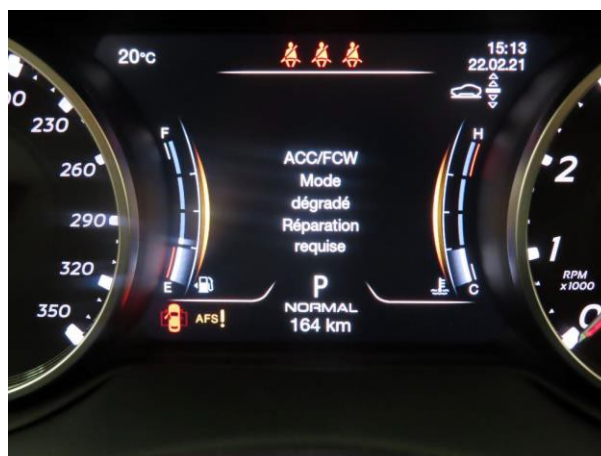
Malfunction of the ADAS systems related to the HALF (HAPTIC Lane Feedback, i.e. Forward Looking Camera) module.

The following error messages can be displayed on Cluster, an example is shown in Figure 1:

- ACC/FCW Limited Functionality | Service Required
- Adaptive Front Lighting System Not available | Service required
- Lane Keeping Assist not available
- Traffic Sign Assist Not available | Service required
- Active Blind Spot Assist not available

**Figure 1:** Possible warning message related to one of the ADAS systems linked to the HALF module.

1. Preliminary checks:
  - a. Verify the correct installation of the HALF module on the mounting bracket.
  - b. Verify the integrity and cleanliness of the windscreen in the area related to the HALF module.

- c. Save DTCs+Parameters report of all the ECUs which have errors.
2. If the DTC C2212-00 ECU in plant mode is set in the HALF ECU, this means that it is in plant mode. Use the Diagnostic Tool to perform the HALF > Active Diagnosis > Exit plant mode and then perform the calibration as described in the Workshop Manual Procedure 08.71.226 – 40 LANE ASSIST CAMERA MODULE - Adjustments. If there are other DTCs in the HALF and DASM modules, try to delete them and then carry out the calibration.

3. If it's impossible to delete the DTC and complete the calibration, check the power supply, connectors, and grounds as per the wiring diagram FE0526 - Lane Departure Warning (LDW). Also, check the connections between HALF and DASM.
