# AfterSales Diagnostic Sheet

**MAS002757**  
(BOL 21-24)

## Crank and Intermittant No Start start of the engine - RFH- (Radio Frequency Hub) ESCL connectors

**Models:** M156/M157 with Electronic Shaft Block OPT

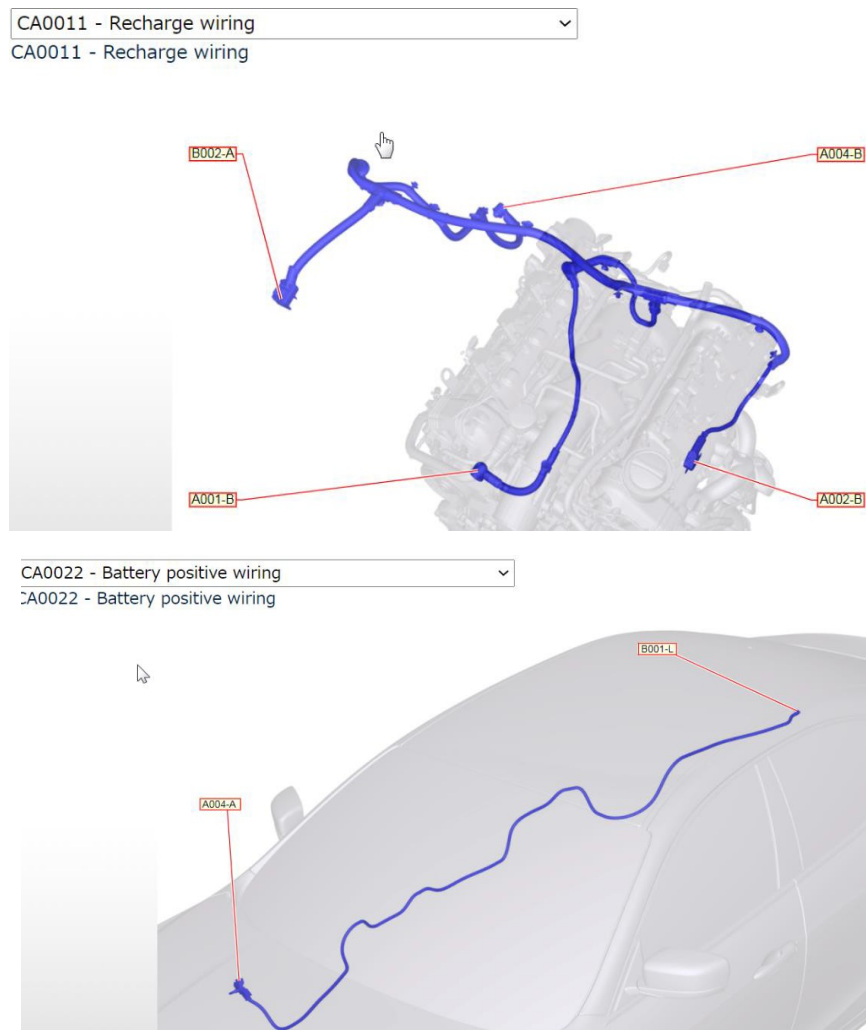
**Figure 1:** Position of the Recharge Wiring (upper picture) and of the Battery Positive Wiring (lower picture)

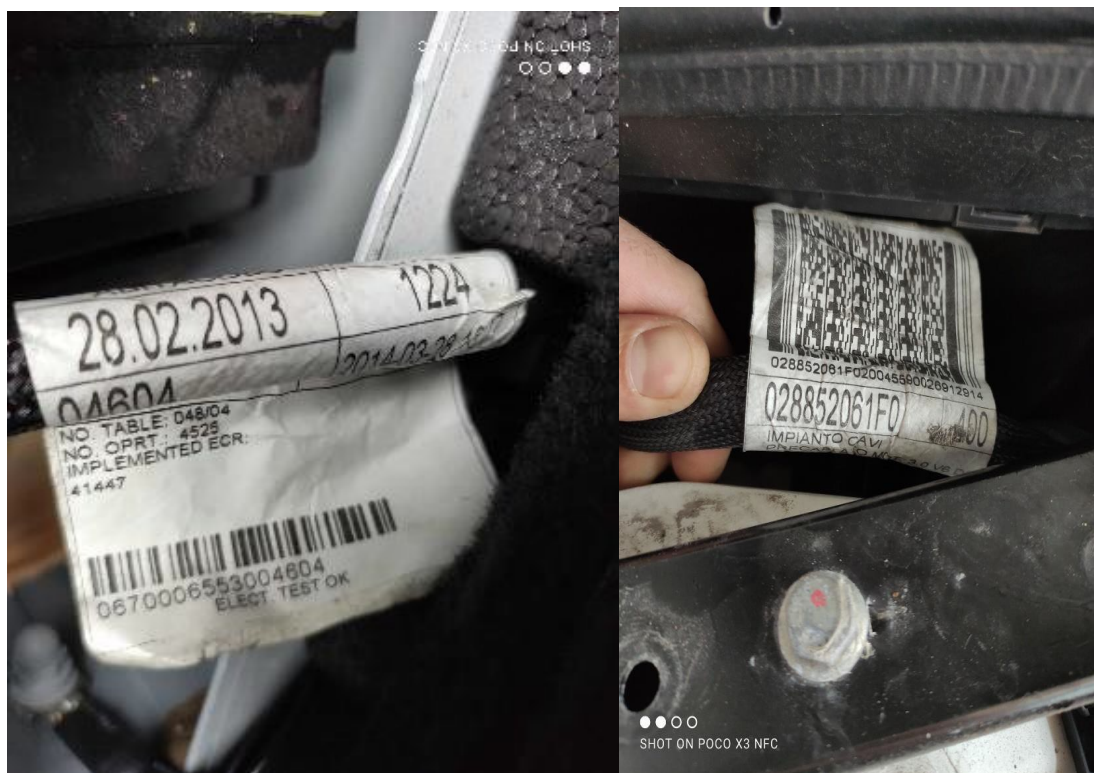
**Figure 2:** Examples of the Traceability Labels of the Battery Positive Wiring (left) and the Recharge Wiring (right).

Also attach pictures of the Traceability Information Labels of the Battery Positive Wiring and of the Recharge Wiring.

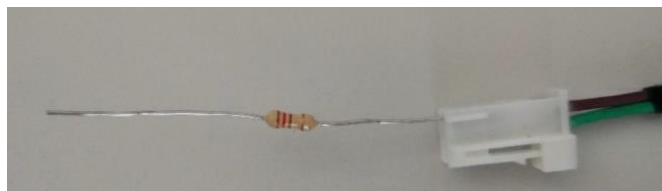
**Figure 4:** Example of connector and resistor for the drag test.

Be sure to pay attention to the correct tightness of the connectors pins, loose pins could cause faulty contacts and possible sporadic issues difficult to be diagnosed and not identifiable by means of an electrical continuity test.
