SIB 51 13 14

Trunk Lid Does Not Open Completely

2021-09-08

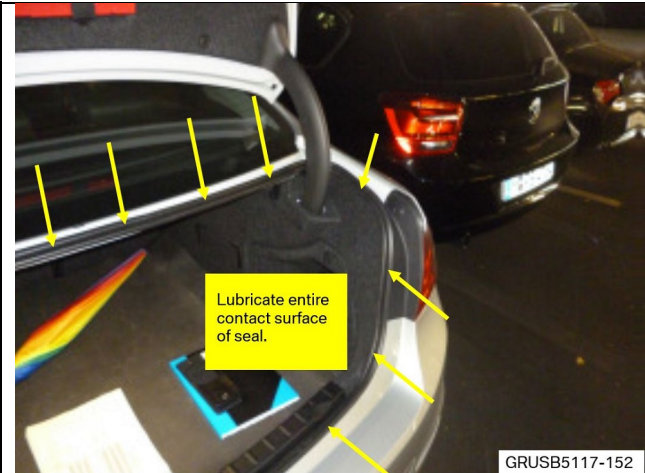
Adhesion between body and unlubricated trunk lid/hatch seal.

1. Clean the trunk seal using water and a clean cloth.

Clean and lubricate the trunk lid/hatch seal.

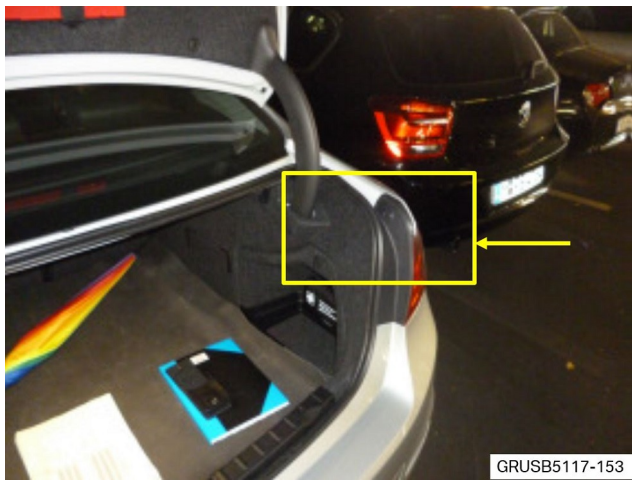
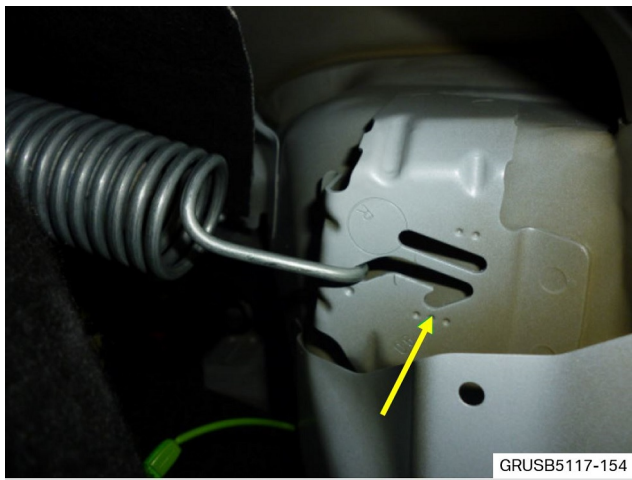
Incorrectly installed trunk lid tension spring may also not fully open a trunk lid.

4. For F30, F32, F80, F82 partially remove the trunk liner to inspect the trunk spring

5. Ensure the spring is attached to the rearmost hook (shown by the arrow). If it is, continue troubleshooting, this bulletin does not apply.

If it is not, reattach it to the rearmost hook and retest.
