01-18-13 - MIL ON DTC P0401 Exhaust Gas Recirculation Flow Insufficient

Release date: 11/01/2021

Technical Service Bulletin

Transaction No: 2034898/20

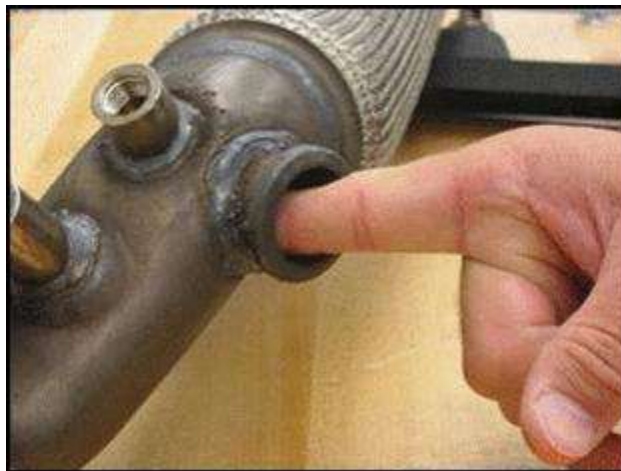
Figure 1

- Remove the EGR filter from the Diesel Particulate Filter (DPF) and swipe the inside of the exhaust pipe at the EGR filter connection point using a clean cloth or your finger. See figures 1 and 2 below.

If your finger or the cloth comes out with black soot:

- Replace the DPF & EGR filter together.
- Smoke test the charge air system for leaks (see procedure below).
