## SERVICE ACTION

<b>Reference number:</b>	SA-42-1543	<b>Issued:</b> 06 August 2021
<b>Subject:</b>	Incorrect Socket for the Wheel Brace	
<b>Model(s):</b>	DBX	
<b>VIN Range:</b>	Refer to the separately published list of affected Vehicle Identification Numbers (VINs)	
<b>Applicable to:</b>	All Dealers	
<b>Distribute to:</b>	<b>After Sales Manager</b> <b>Executive Manager</b> <b>Service Manager</b> <b>Sales Manager</b>	<b>Warranty Staff</b> <b>Technician(s)</b> <b>Parts Staff</b>

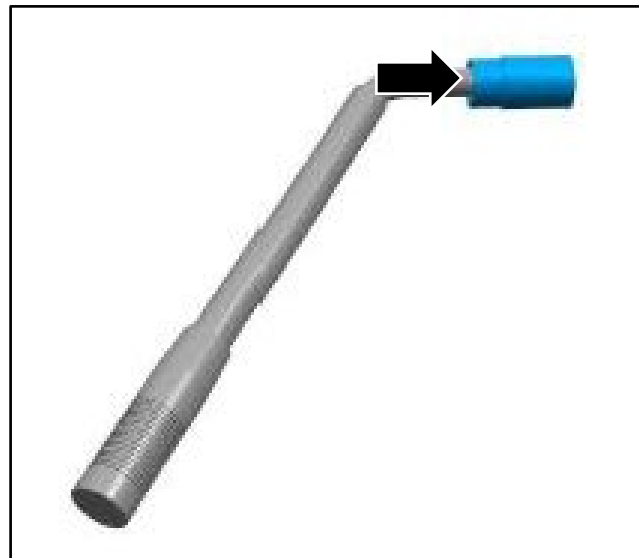
Figure 1

Aston Martin has discovered some DBX vehicles have an incorrect 21/23mm socket installed on the wheel brace.

1. Inspect the size of the socket for the wheel brace.  
If a 21/23mm socket is installed go to step 3. (refer to Figure 1).

2. If a 17/19mm socket is installed no further action is necessary.
3. Remove the 21/23mm socket and install the new 17/19mm socket to the wheel brace (refer to Workshop Manual Procedure 42.01.AT).
