QUARANTINE NOTICE

| Reference number: | QN-01-1546 | Issued: 31 August, 2021 |
| Subject: | Install New Screws for the Front Splitter | |
| Model(s): | Vantage F1 Edition | |

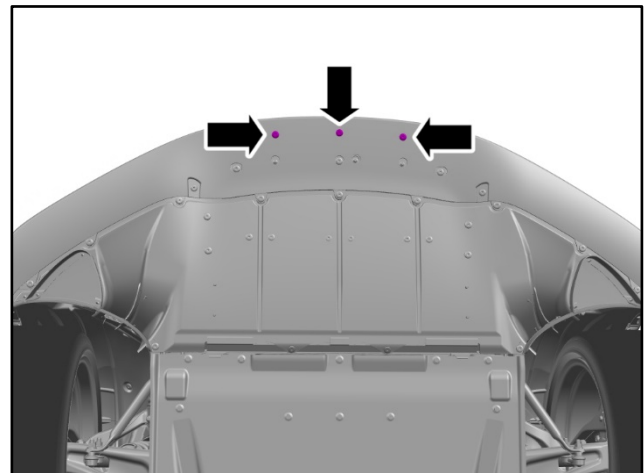
Figure 1

Aston Martin has identified some Vantage F1 edition vehicles that may not have the correct front splitter screws installed. To correct this problem, do the workshop procedure that follows.

1. Lift the vehicle and make it safe.
2. Remove the incorrect screws for the front splitter (refer to Figure 1).
If the screws for the front splitter are not installed go to step 3.

3. Install the correct screws to the front splitter.
4. Lower the vehicle.
