High Transmission Fluid Temperature Warning Message

Service Category Drivetrain

Section Automatic Transmission/Transaxle

YEAR(S)	MODEL(S)	ADDITIONAL INFORMATION
2019 - 2021	Tundra

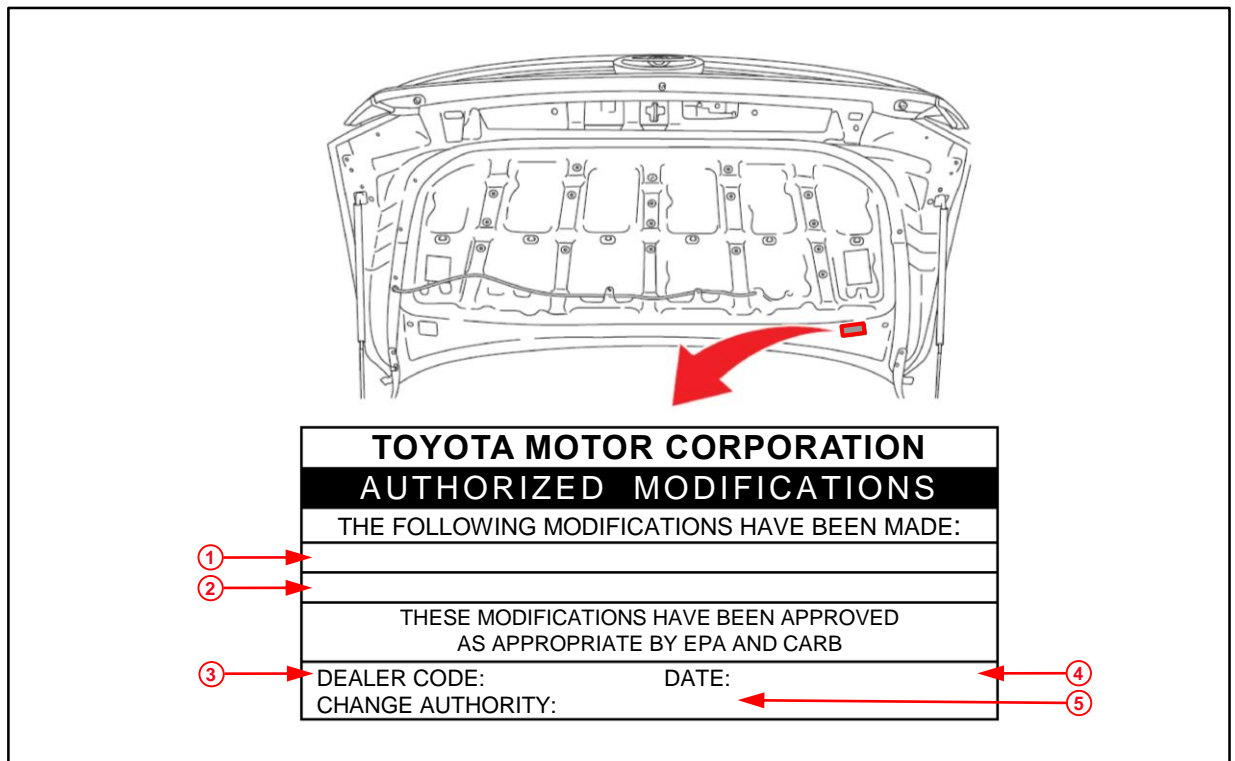
Figure 1. Location of Authorized Modifications Label on 2019 – 2021 Tundra

2. Use Techstream to confirm if the ECM (PCM) calibration has been updated and check for the Authorized Modifications Label affixed to the vehicle in the location shown below. Is the calibration ID listed in Techstream and on the label the latest ECM (PCM) calibration?
 - **YES** — This bulletin does NOT apply. Continue diagnosis using the applicable Repair Manual.
 - **NO** — Continue to step 3.

- Prepare and install the Authorized Modifications Label.
 - Using a permanent marker, enter the following information on the label:
 - ECM (PCM) part number [*Refer to the **Parts Information** section for the **NEW PART NUMBER***]
 - Calibration ID(s) [*Refer to the **Calibration Information** section for the **NEW CALIBRATION ID***]
 - Dealer Code
 - Repair Date
 - Change Authority [***This bulletin number***]
 - Install the Authorized Modifications Label onto the vehicle at the location shown in Figure 1. The Authorized Modifications Label is available through the MDC, P/N 00451-00001-LBL.
- Test-drive the vehicle to confirm proper operation.
