Squeak Noise Over Uneven Surfaces With Suspension in Low Height Position

Service Category Suspension

Section Rear Suspension

YEAR(S)	MODEL(S)	ADDITIONAL INFORMATION
2018 - 2020	LX570

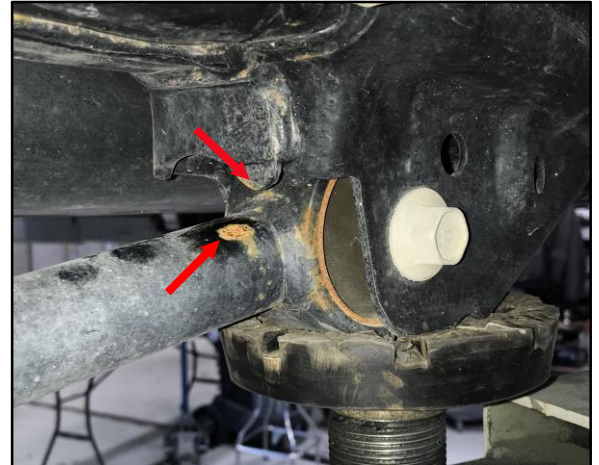
Figure 1.

1. Confirm the condition exists.
Set the suspension height to neutral or high and visually inspect the passenger rear lower control arm and lower control arm support bracket.
Are there signs of contact/witness marks between the two components?
 - **YES** — Sublet the vehicle to a qualified collision repair facility for repair.
 - **NO** — This bulletin does NOT apply. Continue diagnosis using the applicable Repair Manual.

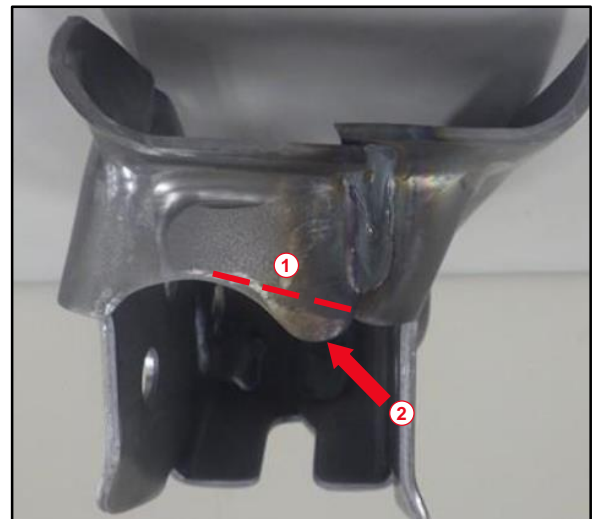
Figure 2.

1	Cut Line
2	Excess (Remove Less Than 5 mm)

2. Disconnect the lower control arm from the bracket.
Refer to TIS, applicable model and model year Repair Manual:
 - 2018 – 2020 LX 570:
Suspension – Rear Suspension – “Rear Suspension: Rear Lower Arm: [Removal](#)”
3. Using masking tape, mark the support bracket to use as a guide for removing excess material.

- Using a cut-off wheel, remove the excess material from the control arm bracket.

Do NOT remove more than 5 mm. Removing more than 5 mm could negatively impact the strength of the component.
