LIMITED SERVICE CAMPAIGN 21TD03

CERTAIN 2016 – 2019 Model Year Double Cab Tacoma

CENTER HIGH-MOUNTED STOP LAMP – WATER LEAK

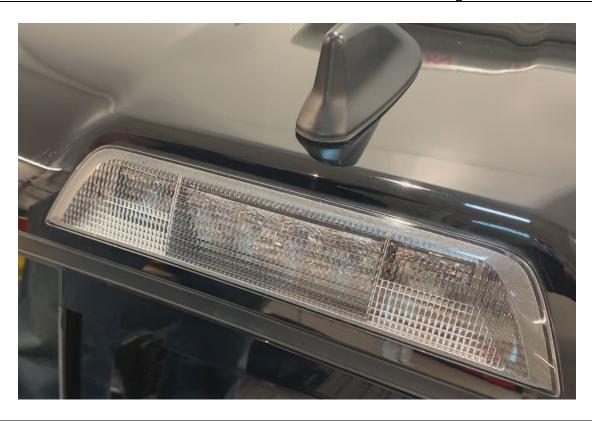
The Center High-Mounted Stop Lamp on the involved vehicles has a seal between the lamp and the vehicle body which can deteriorate over time. If the seal deteriorates sufficiently, water from outside the vehicle could leak into the vehicle cabin through the seal.

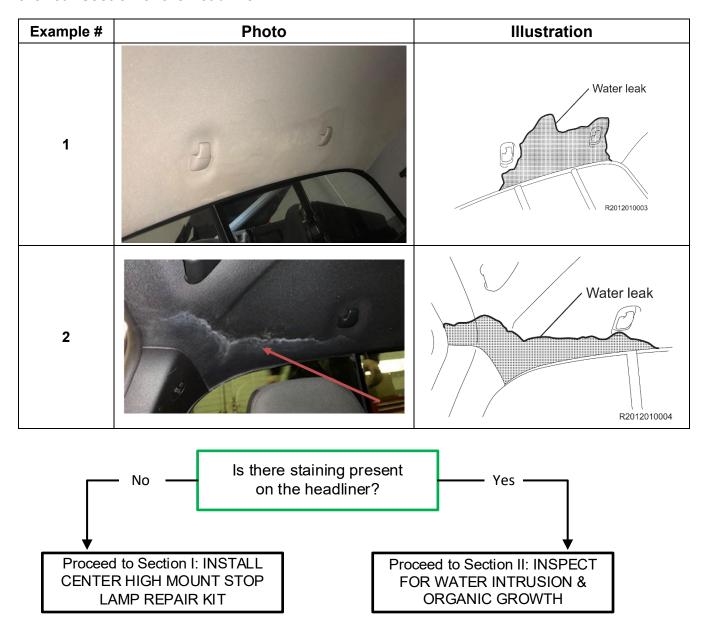
a. Visually inspect the rear section (above the rear window) for evidence of water intrusion stains on the headliner. Water stains will usually be noticeable for discoloration of the visual surface.

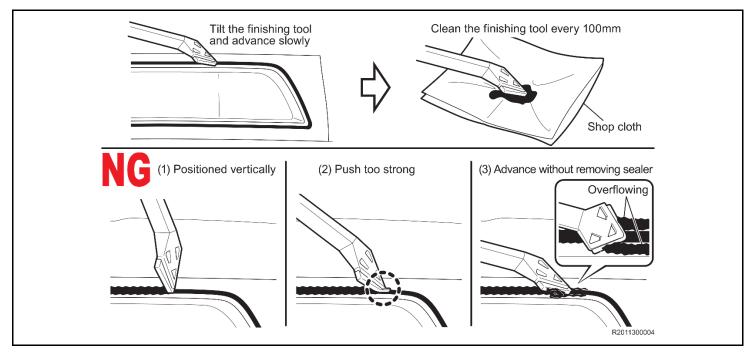
e. Confirm that the sealer is applied well between the center high mount stop lamp and body without any gaps or bubbles.

Note: If there are any gaps or bubbles, add enough sealer to the missing points and push in using the finishing tool.

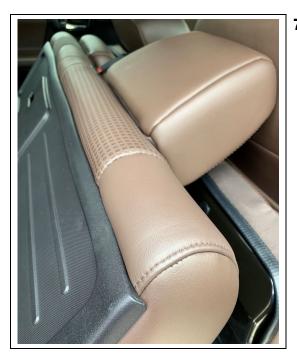
- a. Pull forward on the carpet under the rear seat and fold it on top of the storage bins.
- b. Check the floorboard section for signs of water intrusion and/or organic growth.
