Tech Tip T-TT-0671-21

Subject		Market
Roof Rail Gap to Roof		USA
Service Category	Section	
Vehicle Exterior	Exterior Panels/Trim	
Applicability		
2022 Toyota Corolla Cross

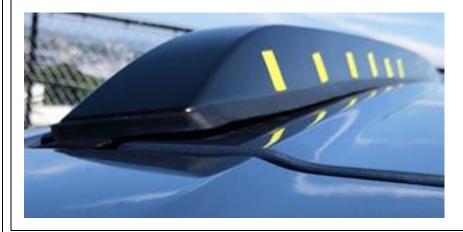
Some 2022 Corolla Cross vehicles that are equipped with roof rails may exhibit a gapped fitting condition at the inner rear corners between the roof rail protector and the roof panel.

- Currently, there is no confirmed repair for this condition.
- Please do <u>NOT</u> attempt to repair this condition if it is identified.
- CQS strongly encourages the submission of field reports related to this condition to include:
 - Measurement data between roof rail protector and roof panel
 - Ambient air temperature at time condition was identified
