GROUP	MODEL
ELE	2018-2019MY Sorento (UMa)
NUMBER	DATE
248	November 2021

TECHNICAL SERVICE BULLETIN

OUTSIDE REAR COMBINATION LAMP HARNES REPLACEMENT

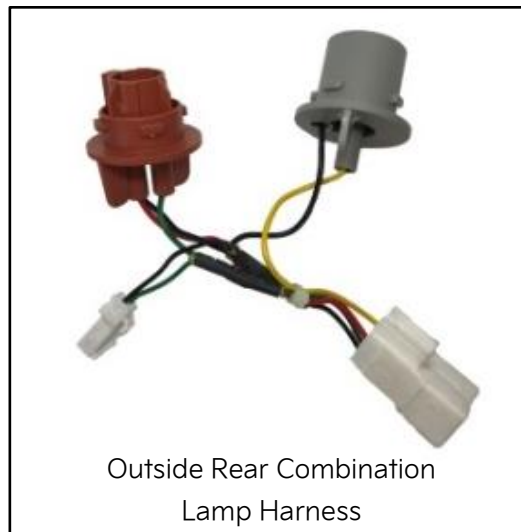
This bulletin provides the procedure to replace both outside rear combination lamp harnesses on some 2018-2019MY Sorento (UMA) vehicles, produced from January 2, 2018, through September 30, 2018, which may exhibit an intermittent inoperative brake light with the possibility of a "Check brake light" warning on the instrument cluster display. Follow the procedure outlined in this bulletin to replace the outside rear combination lamp harnesses.

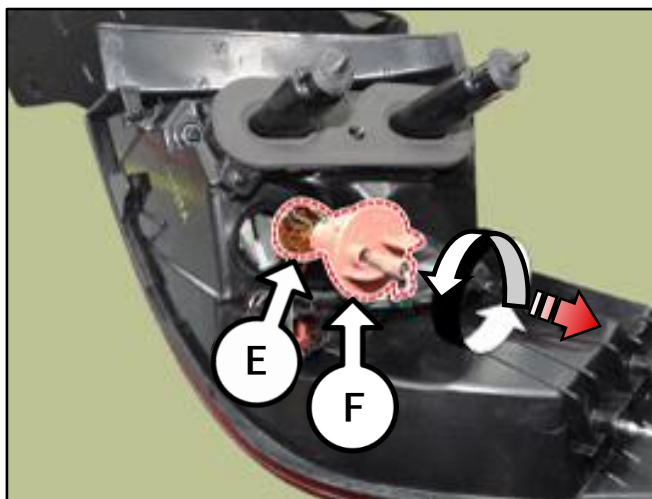
If a brake lamp bulb is inoperative, replacement is required.

- 4a. Remove the rear combination lamp.
- 4b. Then remove the turn signal lamp bulb (E) by turning the socket (F) counterclockwise.
