Technical Service Bulletin

66 Wheel arch trim on the rear door is loose

66 21 76 2064998/1 November 12, 2021.

Model(s)	Year	VIN Range	Vehicle-Specific Equipment
Q8	2019 - 2021	All	Not Applicable
SQ8, RS Q8	2020 - 2021	All	Not Applicable

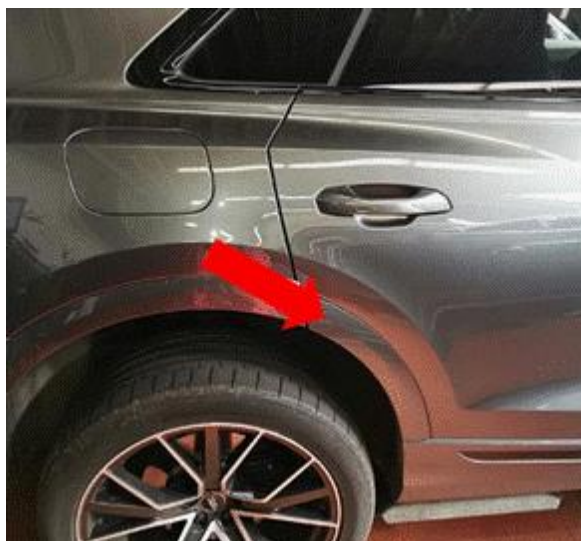
- The bond has failed for this section of the wheel arch trim.

1. Figure 1 shows the specific section of the rear wheel arch trim that may have debonded.

Figure 1. Rear wheel arch trim section affixed to rear door at issue.

Replace the affected wheel arch trim using the repair process in ElsaPro. Pay particular attention to the surface preparation of the bonding surface on the door. Ensure it is entirely free of any contamination that could compromise the adhesion of the new wheel arch trim section.

Since the issue described in this TSB can affect either the right or the left side inspect the bonding integrity of the opposite side of the side being repaired. Address if necessary.

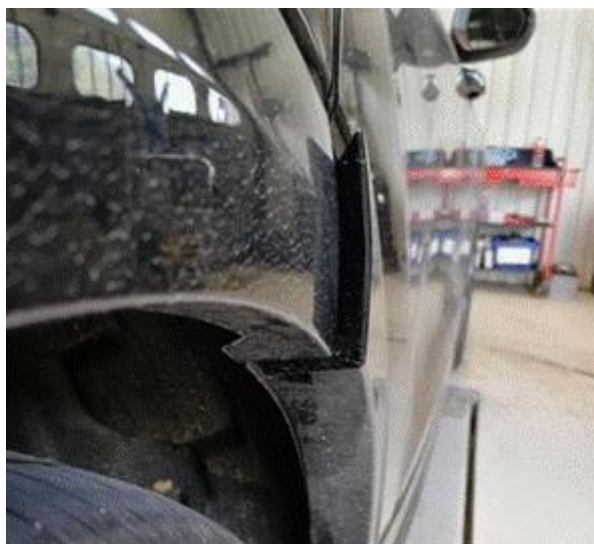
2. Figure 2 depicts a loose wheel arch trim section as it may be discovered.

Figure 2. Debonded rear wheel arch trim section.

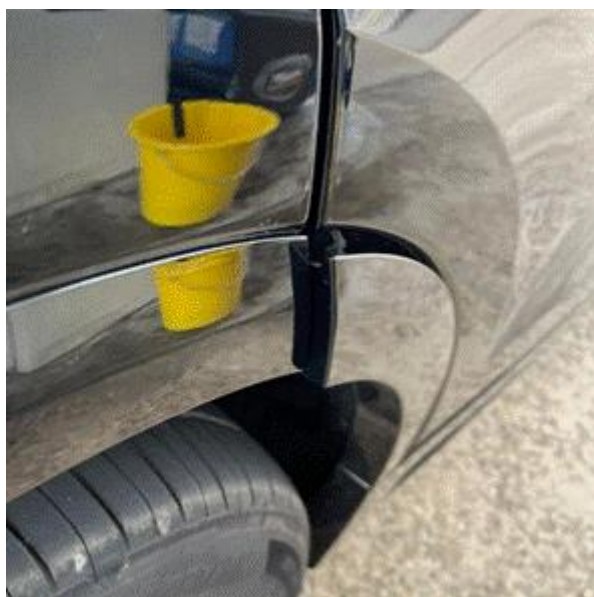
3. Figure 3 depicts an alternative view of a debonded rear wheel arch trim.

Figure 3. Debonded rear wheel arch trim section.
