Technical Service Bulletin

66 Paint is peeling on the front spoiler on the inside of the wheel housing opening

66 21 77 2065000/1 November 12, 2021.

Model(s)	Year	VIN Range	Vehicle-Specific Equipment
Q3	2019 - 2020	All	Not Applicable

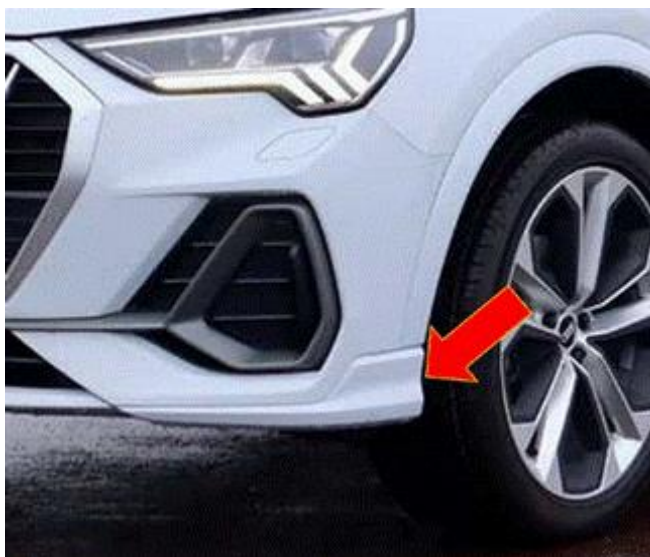
- The paint peel is confirmed on visual inspection. No outside influence (e.g. stone chips, scuffs, etc.) is found. It begins inside the wheel housing and, in advanced stages, migrates to the front of the lower spoiler lip.

- The root cause of the paint peel is due to poor paint adhesion in the production process of the front lower spoiler (Figure 1).

Figure 1. Location of paint peel on the front lower spoiler.

Should the front lower spoiler exhibit the condition specifically described in this TSB do not refinish or repaint the front lower spoiler. The front lower spoiler must be replaced.

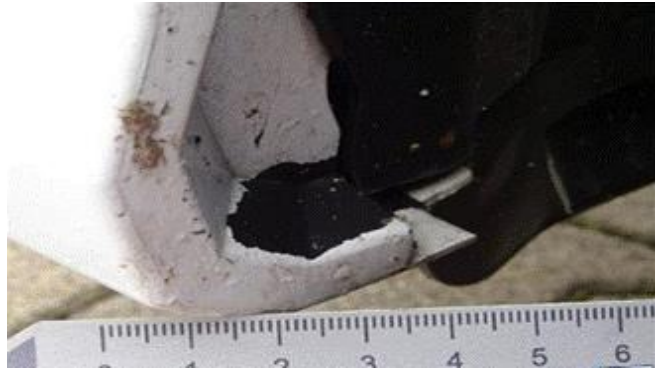
2. The area of the paint peel at issue is located as shown in Figure 2.

Figure 2. Paint peel location on the front lower spoiler.

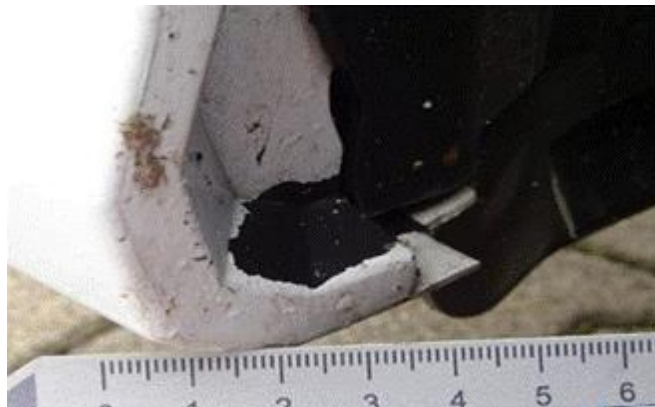
3. Figure 3 shows the origin of the paint peel condition.

Figure 3. Interior view of the paint peel on the front lower spoiler.

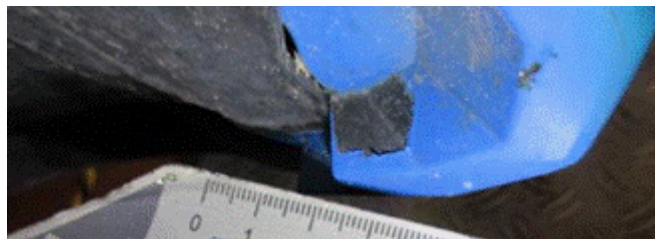
4. Figure 4 shows an alternative view and extent of the loss of adhesion.

Figure 4. Paint peel as discovered from the right side of the front lower spoiler.
