66 Door cover trim is loose

66 21 78 2065001/1 November 13, 2021.

Model(s)	Year	VIN Range	Vehicle-Specific Equipment
Q8, SQ8, and RS Q8	2020 - 2021	All	Not Applicable

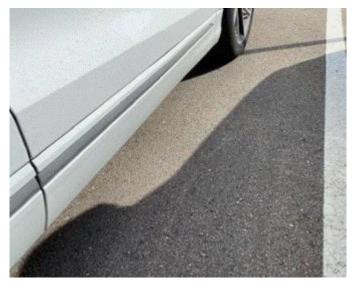
- When the front door trim cover was installed in production one or more door trim clips may have been incorrectly engaged and subsequently damaged during the installation process. This issue may be present on either the left or right front doors.
- 2. Figure 1 depicts this condition as it may appear.

Figure 1. Visible gap present between the front door trim cover and the outer door panel.

Replace the front door trim according to the repair specifications in the Elsa Repair Manual. Since this issue may be present on either the left or right front doors carefully inspect both front doors for this condition and repair as necessary.
