Technical Service Bulletin

91 SOS Emergency call function deactivated message in the cluster, DTC U153E00 is stored in the telematics module

91 21 49 2055945/8 November 17, 2021. Supersedes Technical Service Bulletin Group 91 number 21-36 dated September 22, 2021 for reasons listed below.

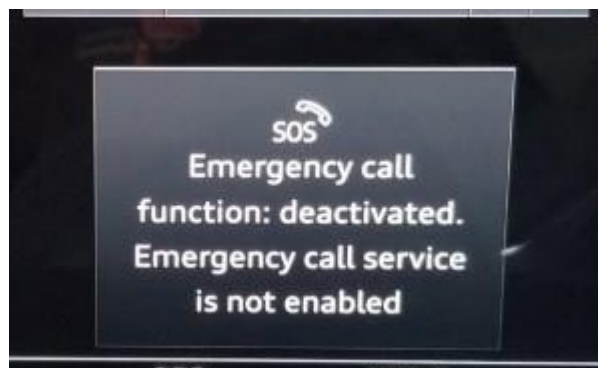
- The warning message “SOS Emergency call function deactivated” is seen in the instrument cluster (Figure 1 or 2).

Figure 1. SOS warning in the instrument cluster.

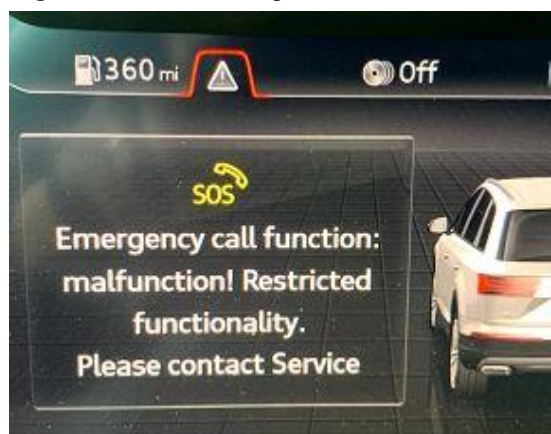
Figure 2. SOS warning in the instrument cluster.
