Technical Service Bulletin

91 MIB3: navigation is permanently initializing/malfunctioning, DTC B126CF0 and/or B126CF1 is stored in the 005F

91 21 50 2062115/7 November 17, 2021. Supersedes Technical Service Bulletin Group 91 number 21-30 dated September 15, 2021 for reasons listed below.

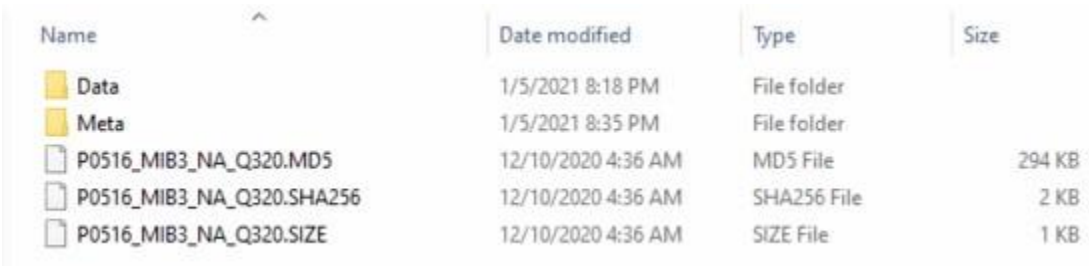
Figure 1. Example of how the extracted files appear.

1. Contact TAC to receive a download link with instructions for the current MIB3 navigation database.
2. Avoid using IE (Internet Explorer) and download both files from the download link provided by TAC “download folder” then go to the PC “C drive”.
3. Find the 32GB USB drive, right-click the USB icon, select format and select “**NTFS**” (if the drive is formatted in FAT32, it might not be possible to update the vehicle via the customer update menu).
4. Formatting the USB drive erases **all** files on the drive.
5. Open 7-zip (www.7zip.org if not loaded) and locate the NAV files on the C drive and select both files and then click the extract icon.
6. Once the files are extracted open the new folder (Figure 1).

7. Open the USB drive that was formatted to NTFS and copy the files as seen above directly to the drive (they CANNOT be in a single folder but just as they are displayed above).
8. Then eject the USB drive.
9. In ODIS, under Guided Fault Finding/Guided Functions, select and execute the following test plan: *Self test >> Diagnostic capable system >> 005F - Information Electronics Control Module 1 -J794- (MIB 2+ or MIB 3) >> 005F - Information Electronics 1, functions / 005F – Basic Setting >> **Erase navigation databank.***
10. End the diagnostic session and await a vehicle sleep cycle.
11. Insert the USB drive into the vehicle, then go into the MMI settings section; *MMI settings >> select system maintenance >> software update.*
12. At this point the software update should be available if the prior steps are performed properly.
