GROUP	MODEL
ELE	2022MY Carnival (KA4) w/AVN 5.0W
NUMBER	DATE
249	November 2021

TECHNICAL SERVICE BULLETIN

SUBJECT: **SERVICE ACTION: AVN 5.0W SOFTWARE UPDATE FOR Wi-Fi HOTSPOT FUNCTION (SA488)**

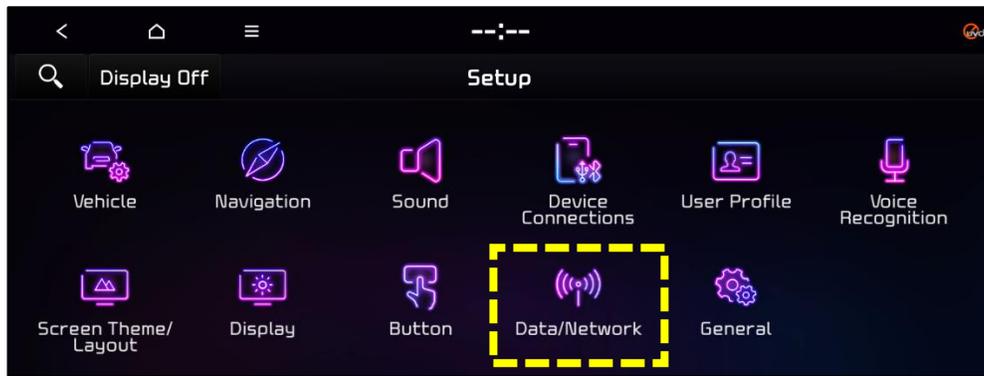
Shown below: If "Data/Network" appears in Setup menu, then Wi-Fi Hotspot is enabled.

If "UVO" is displayed instead, then <u>software update is needed</u> .
--	---

This bulletin provides information to update the AVN 5 Wide software for the Wi-Fi Hotspot function on some 2022MY Carnival (KA4) vehicles, produced from January 15, 2021 through November 10, 2021. If the head unit displays the "UVO" icon instead of the "Data/Network" icon in the 'Setup' menu (shown below), then the software update is required. Follow the procedure outlined in this publication to update the AVN 5 Wide software to setup the Wi-Fi Hotspot function. Before conducting the procedure, verify that the vehicle is included in the list of affected VINs.
