# HUSQVARNA TECHNICAL BULLETIN HTB2110

OCTOBER 1, 2021

## CLUTCH SLAVE CYLINDER INSPECTION AND REPLACEMENT IF NEEDED

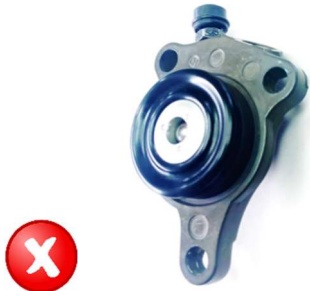
Husqvarna Motorcycles North America, Inc. has determined that a defect which relates to motor vehicle safety exists with certain 2018, 2019 and 2020 motorcycles listed above pertaining to the clutch slave cylinder. On affected motorcycles there is a possibility that the bellow style gasket can be damaged caused by deviations during assembly. Damage to the bellow gasket may affect the function of the clutch slave cylinder. This could result in the rider noticing a change in shifting behavior and the clutch becoming inoperable to the point where the clutch will not disengage when the clutch lever is pulled in. To ensure the highest level of safety, performance, reliability and customer satisfaction, it is necessary to replace the clutch slave cylinder on all affected motorcycles that have a bellow style gasket clutch slave cylinder mounted (Fig. 1).

The cause of the defect is due to design of the originally mounted clutch slave cylinder that has a bellow style gasket that can be damaged. To remedy this defect, a new clutch slave cylinder without the bellow style gasket must be installed on all affected motorcycles (Fig. 2).

Fig. 1 - Version with bellow style gasket  
(p.n. 79432061144)

Some motorcycles might already have the new version clutch slave cylinder mounted from a customer replacement. Therefore it is first necessary to inspect the clutch slave cylinder to determine which version is installed. If the bellow style gasket clutch slave cylinder is mounted it must be replaced by the new version (p.n. 76132061044). If the new version is already mounted then you must reinstall the new style slave cylinder using a new gasket and o-ring on the slave cylinder and a new lock washer for the front sprocket to seal and remount the components properly.
