Technical Service Bulletin

63 Paint peeling from the rear bumper cover

63 21 74 2064279/2 November 22, 2021. Supersedes Technical Service Bulletin Group 63 number 21-07 dated August 25, 2021 for reasons listed below.

Model(s)	Year	VIN Range	Vehicle-Specific Equipment
Q5, SQ5	2020 - 2021	All	Not Applicable

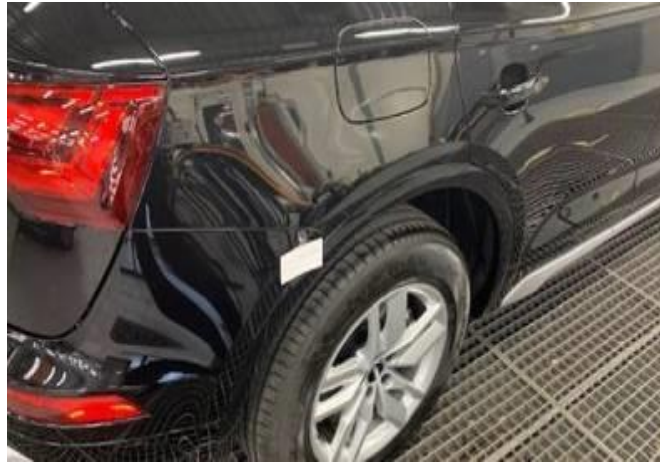
An inconsistency in the production process of the rear bumper cover specifically at the edges that meet the rear side panel caused a weakness making the painted surfaces on these edges prone to paint peel over time. Either the right side, left side or both sides of the bumper cover are affected.

1. Figure 1 shows the area of the bumper cover affected.

Figure 1. Bumper cover edge affected.

Should the condition described in this TSB occur the rear bumper cover is to be replaced. Do not attempt to refinish the original bumper cover. Due to the technical nature of the root cause refinishing the original bumper cover will only reintroduce a subsequent paint peel in these areas of the rear bumper cover over time.

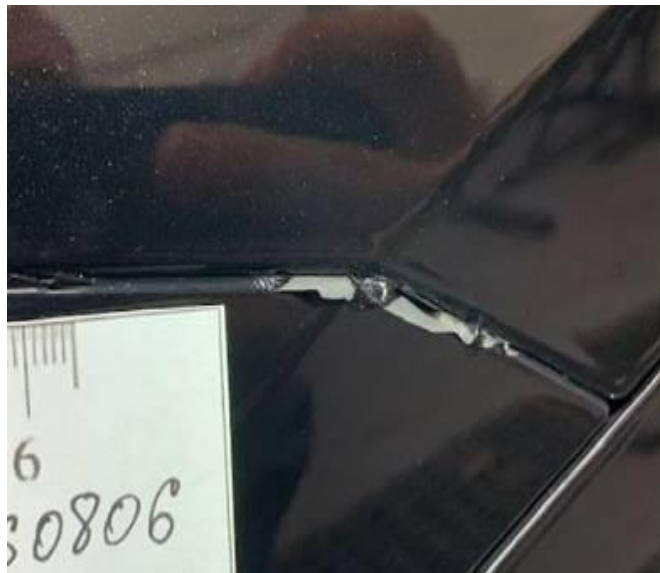
2. Figure 2 shows a close-up view of the paint peel.

Figure 2. Paint peel on the bumper cover edge.

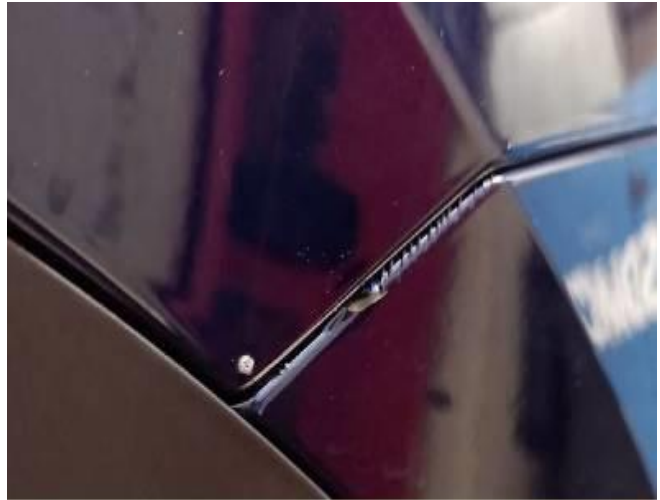
3. Figure 3 shows the condition in its early stages that may evade notice.

Figure 3. Early stages of the peel.

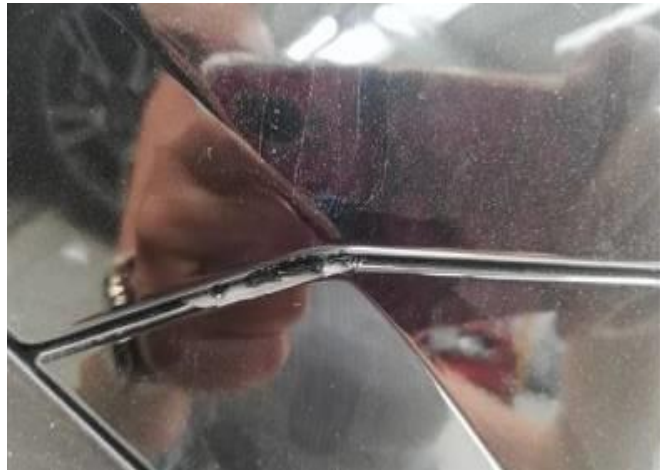
4. Figure 4 shows an intermediate loss of paint in this area.

Figure 4. Moderate loss of adhesion.

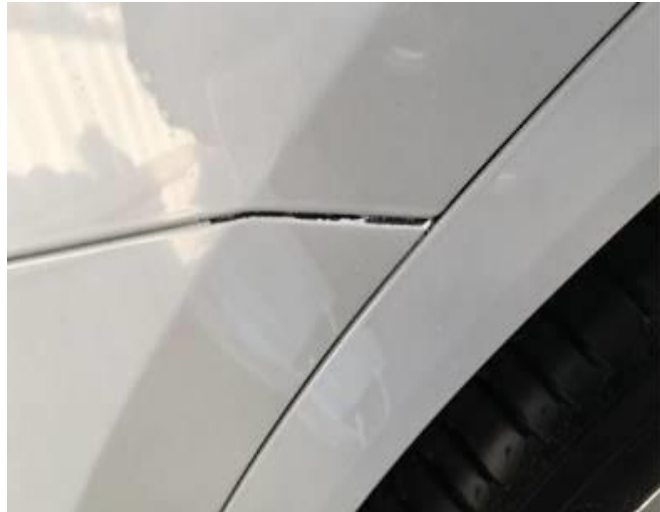
5. Figure 5 shows severe advancement of paint loss on the rear bumper cover.

Figure 5. Advanced paint peel.
