Technical Service Bulletin

90 Instrument cluster: trip odometer and/or clock sporadically resets to zero - MY20

90 21 26 2062368/4 November 24, 2021. Supersedes Technical Service Bulletin Group 90 number 21-18 dated October 25, 2021 for reasons listed below.

| Model(s) | Year | VIN Range | Vehicle-Specific Equipment |
|---|---|---|---|
| Q3 | 2020 | All | Digital Instrument Cluster |

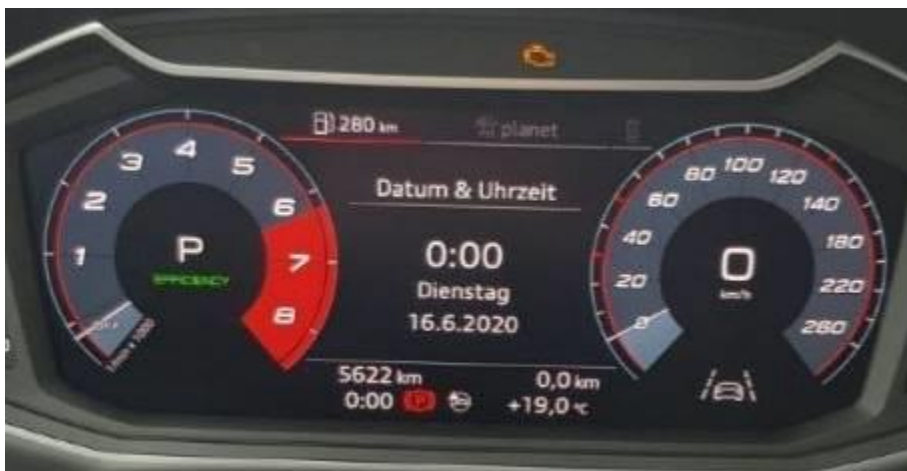
- The trip odometer and/or the clock in the instrument cluster sporadically reset to zero (Figure 1).

Figure 1. Clock and trip odometer reset to zero.

A software issue in the instrument cluster can cause it to reset on start-up clearing the clock and trip odometer.

- Update the instrument cluster using either Method 1 or Method 2 according to TSB 2056558: *91 MIB2+ Software Update Instructions* use SVM code FPKWW4310.

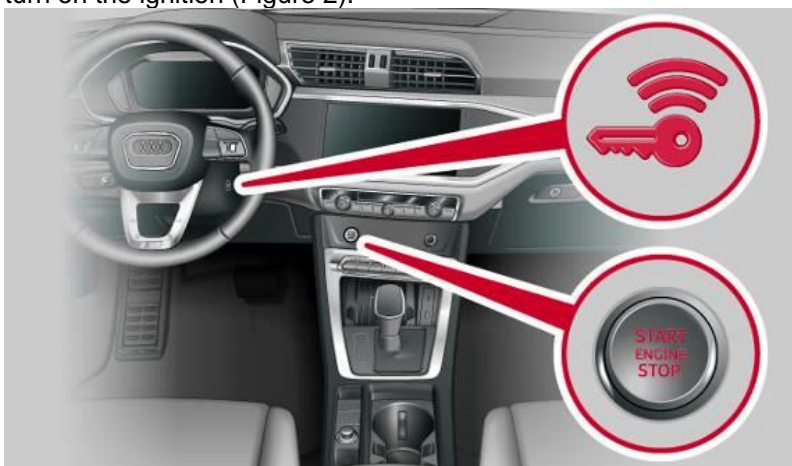
Figure 2. Key reader coil location.

- Affix the vehicle key to the key reader coil before starting the update (for example with adhesive tape), then turn on the ignition (Figure 2).
