# Technical Service Bulletin

## 94 Reverse lamp is inoperative, DTC(s) B12CB15 or B12CC15 stored in the comfort system control module

94 21 51 2063766/2 November 30, 2021. Supersedes Technical Service Bulletin Group 94 number 21-45 dated September 2, 2021 for reasons listed below.

Model(s)	Year	VIN Range	Vehicle-Specific Equipment
Q5, SQ5	2018 - 2020	All	Not Applicable
Q5 PHEV	2020	All	Not Applicable

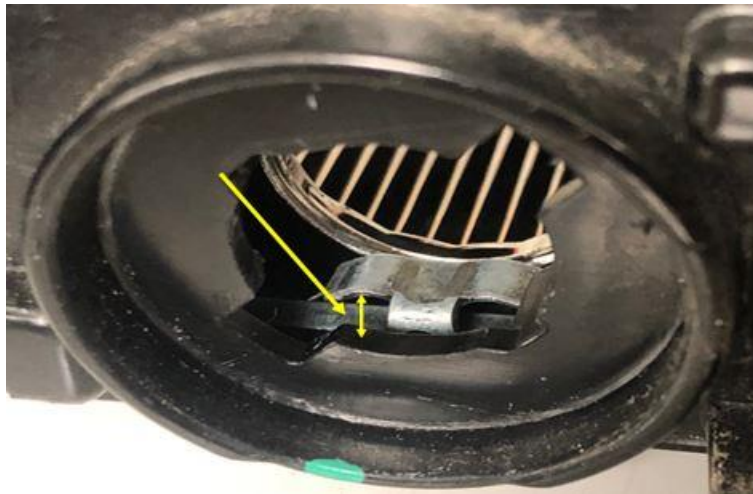
The internal circuit board for the reverse lamp (located in the lamps on the rear bumper) may become separated from the tail lamp housing. When this occurs the metal contact loses connection with the bulb socket.

*Figure 1. Tail lamp contact loose/pulled away from housing.*

1. If the bulb socket contact is loose/pulled away from the housing, the lamp will need to be replaced (Figure 1).

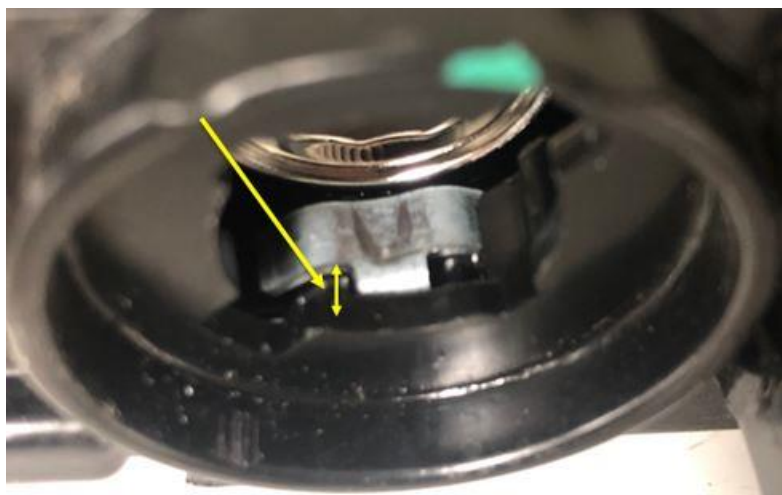
*Figure 2. Lamp contact has separated from housing.*

2. If the bulb socket contact is flush with the housing then no repair is needed (Figure 2).

Continue with normal diagnosis outside of this TSB.
