PASSENGER SEAT BELT WARNING WITHOUT PASSENGER

Bulletin No.: 08-003/21

Last Issued : 11/19/2021

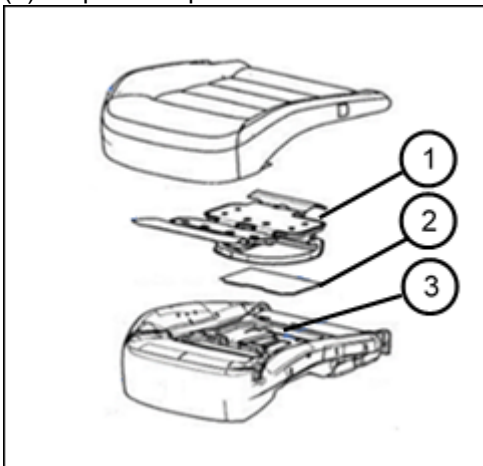
Some vehicles equipped with a seat ventilation system may have the passenger seat belt warning light on, even though there is no passenger in the seat. This concern may be caused by an overly sensitive detection of the occupancy sensor. The weight of the seat ventilation unit may be captured by the occupancy sensor, resulting in a false detection.

To eliminate this concern, the construction of the pad (2) has been changed so that the weight of the seat ventilation unit (1) is spread to parts other than the occupancy sensor (3).

1. Verify the customer concern.
2. Replace the passenger side front seat cushion with a modified one according to MGSS online FRONT SEAT CUSHION TRIM REMOVAL/INSTALLATION.
3. Verify the repair.
