Technical Service Bulletin

REAR DOOR SEAMING WELT COMES OFF WHEN STEPPING IN AND OUT OF VEHICLE

Bulletin No.: 09-033/21

2014-2018 Mazda3 2013-2021 CX-5

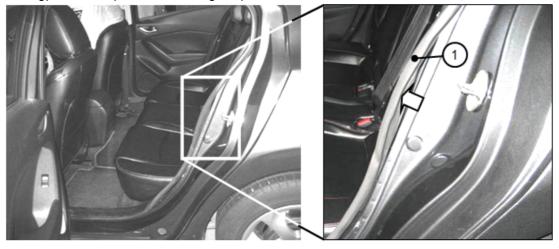
Some customers may complain that the rear door seaming welt (1) comes off when stepping in and/or out of the vehicle. This is caused by the gripping force of the seaming welt being insufficient for frequent usage of the rear seat (vehicle used for ride sharing). No mass production change is planned.

Customers having this concern should have their vehicle repaired using the following repair procedure.

- 1. Verify concern
- 2. Re-install the affected side seaming welt(s) with a double-sided adhesive tape (new service part).
