Technical Service Bulletin

97 Wire harness repairs and documentation

97 21 82 2061976/2 November 22, 2021. Supersedes Technical Service Bulletin Group 97 number 21-78 dated February 18, 2021 for reasons listed below.

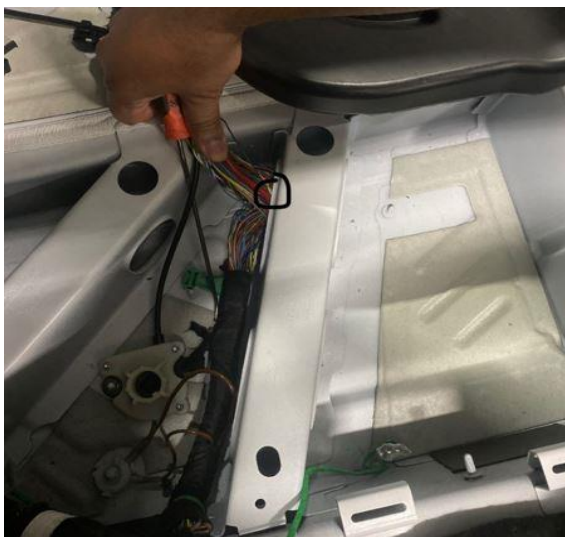
Example: Flexray circuit measured .6 ohm to ground with no components connected to the circuit. Short circuit to ground present on the green FlexRay wire between J743 Dual Clutch T23/1 and J533 Data Bus on Board Diagnostic Interface T54/27. Located damaged wire section underneath the driver seat along the frame rail.

Using the description in the example above, the root cause can be clearly identified in Figure 1.

Figure 1. A perspective view showing the area along the frame rail.

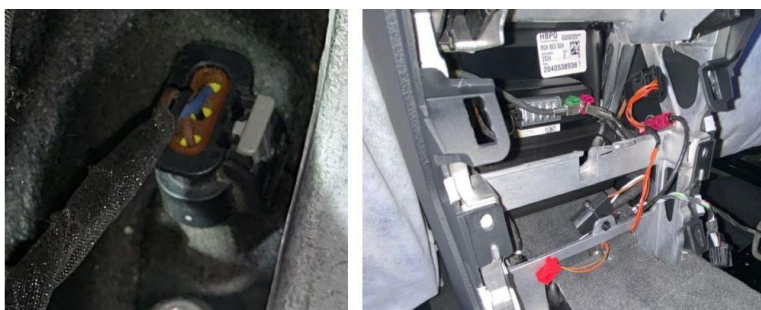
When a harness routing is determined to be the root cause, a photo should be taken to show how the harness was routed in its normal state (Figure 2).

Figure 2. G28 crank sensor harness tight (left), Q5 Wireless charging pad harness tight (right).

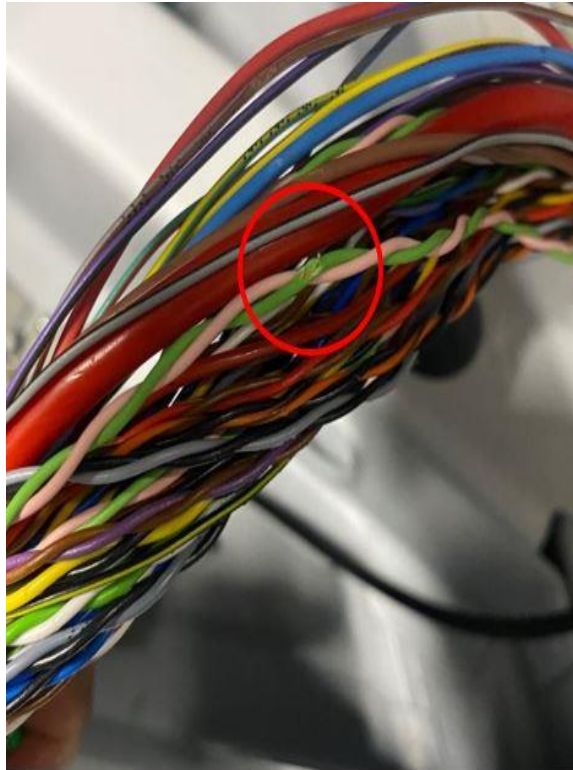
Using the description in the example above, the damage to the FlexRay wire is clearly visible in Figure 3.

Figure 3. Close-up of the damaged wire.

- Overlays may be used for diagnosis.
- Retain the affected section of wire that was removed/faulty.
- Repair faulty sections of the wire using VAS1978B.
