Technical Service Bulletin

Subject: RUST AROUND REAR VIEW CAMERA AND/OR LIFTGATE OPENER SWITCH	Bulletin No.: 09-036/21
	Last Issued : 11/19/2021

2016-2017 CX-3 vehicles with VINs lower than JM1 DK**** **164981 (produced before Jan. 23, 2017)

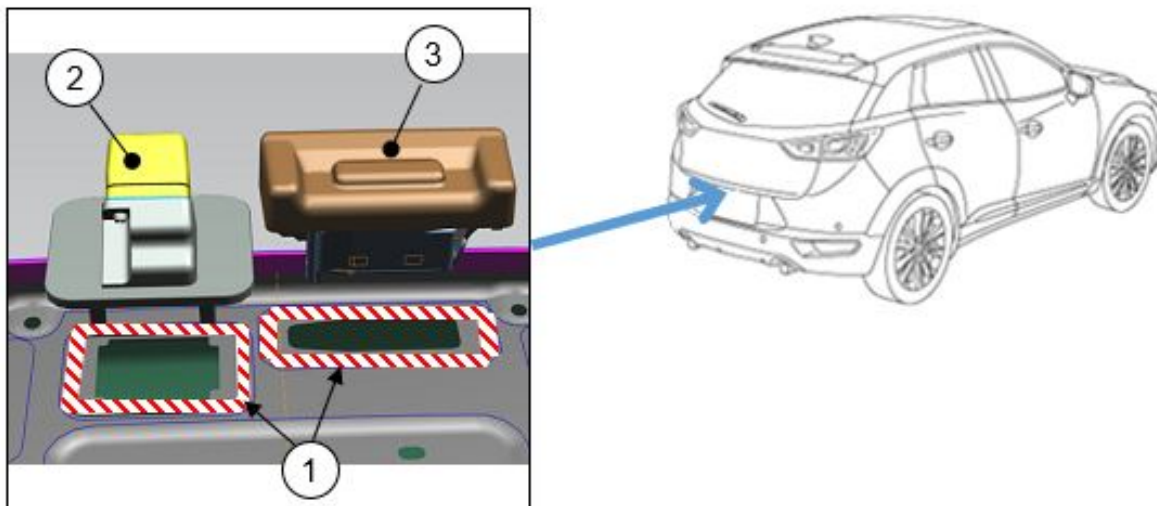
Some vehicles may exhibit rust (1) on the liftgate around the border of the rear mount camera (2) and/or the liftgate opener switch (3). Repair the rust and install a pad to prevent future rust.

NOTE: This service bulletin is only applicable if the rust started from the marked area (1) around the holes. If rust occurs on other areas, this service bulletin is not applicable.

1. Verify customer concern.
2. Repair the affected area of the liftgate by ordinary paint rust damage repair procedure.

NOTE: Repair affected area(s) only. There is no need to repaint the whole liftgate.

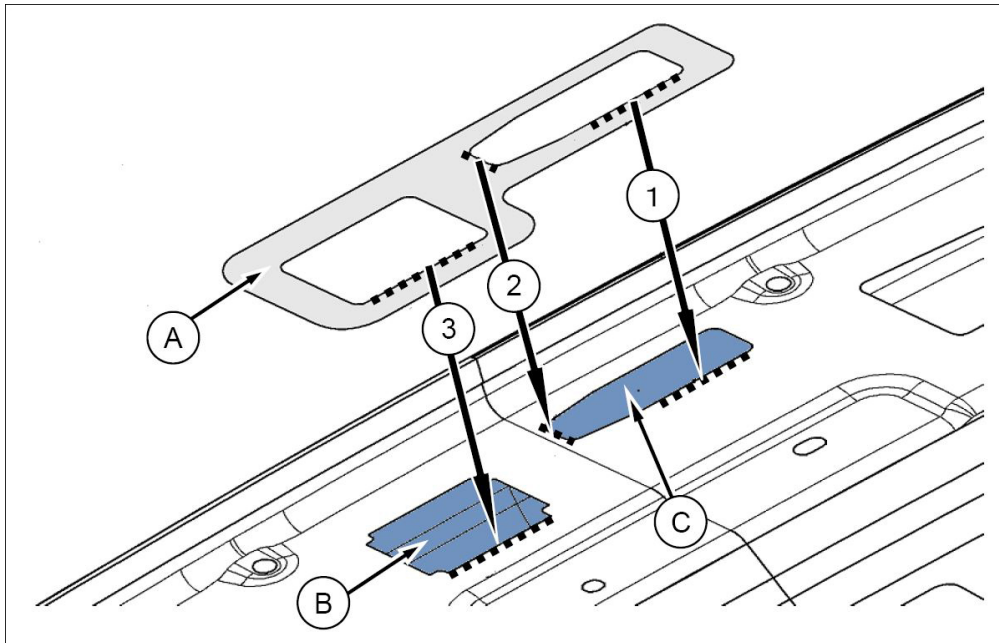
A	Protector Film
B	Installation Hole for Rear Mount Camera
C	Installation Hole for Liftgate Opener Switch

3. To prevent direct interference of the rear mount camera and liftgate opener switch mount bases with the liftgate paint surface, attach a protector film (DBY0-62-864) to the liftgate.

- Degrease the liftgate where the protector film is attached.
- The protector film (A) must not cover the installation holes for the rear mount camera (B) and liftgate opener switch (C). To attach the protector film in the correct position, first align three edges (marked with 1 - 3 in figure) of the protector film with three edges (marked with 1 - 3 in figure) of the installation holes, and then attach the whole protector film without leaving air bubbles.
