# 42-059: Horton Fan Controller Fault – Fan Remains Activated

42-059

Cooling - 42

Diagnostic Trouble Code (DTC) 6637 and/or 3838 is generated due to fan speed and a communication error broadcasted on the communication bus. This results in the fan remaining activated until the DTC is cleared, or the power is cycled On and Off.

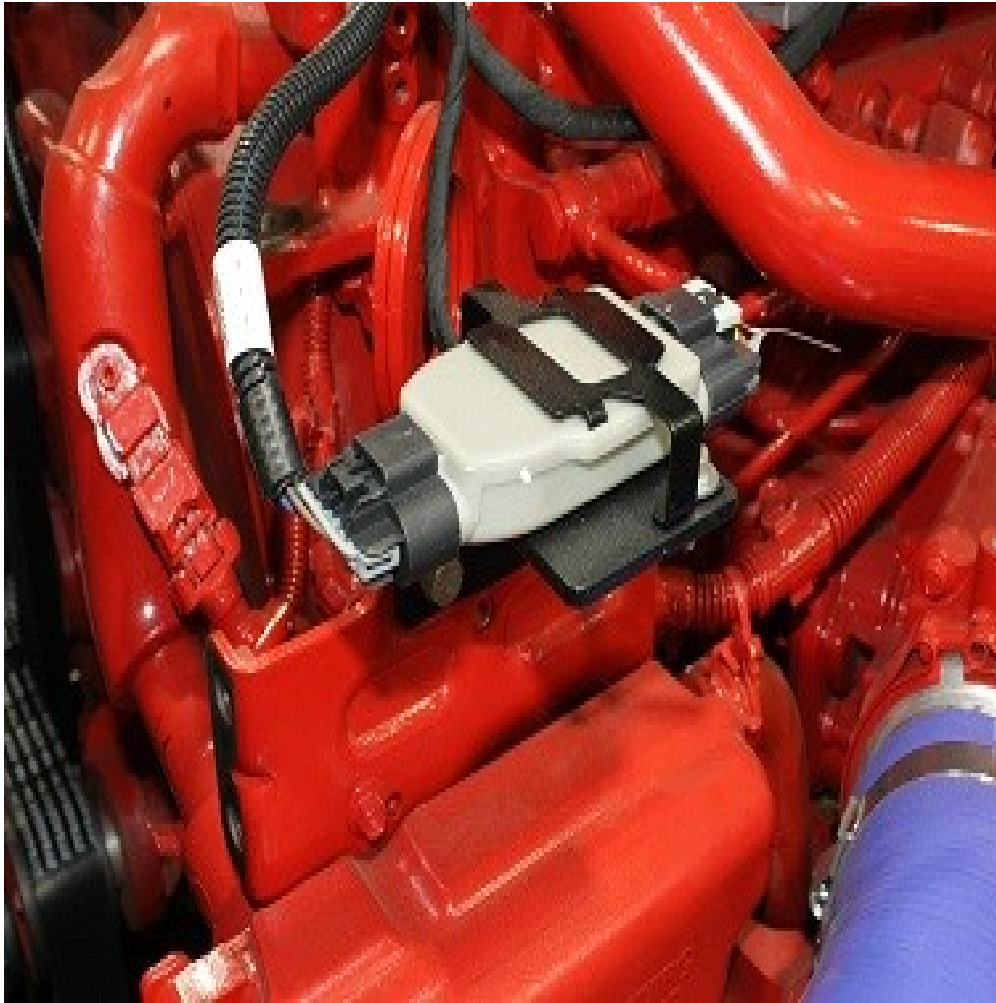
Vehicles equipped with a Cummins X15 engine and a Horton 2 Speed Fan Controller may set a DTC due to fan speed and a communication error broadcasted on the communication bus. This error may result in the fan drive remaining activated until the DTC is cleared, or until the vehicle power is cycled On and Off.

1. Locate the fan controller on the engine.
2. Remove the two electrical connectors on each end.
3. Remove the two 10mm bolts from the bracket holding the controller and remove the controller.
4. Reinstall the new controller, ensuring each end of the controller matches each electrical plug and then reinstall the bracket and the two 10mm bolts.

5. Plug the electrical connectors to the appropriate end of the controller.
