Subject: 42-059 – Horton Fan Controller Fault – Fan Remains Activated  
EXPIRATION DATE: 11/15/2022

# 42-059 Horton Fan Controller Fault - Fan Remains Activated

42-059

Cooling - 42

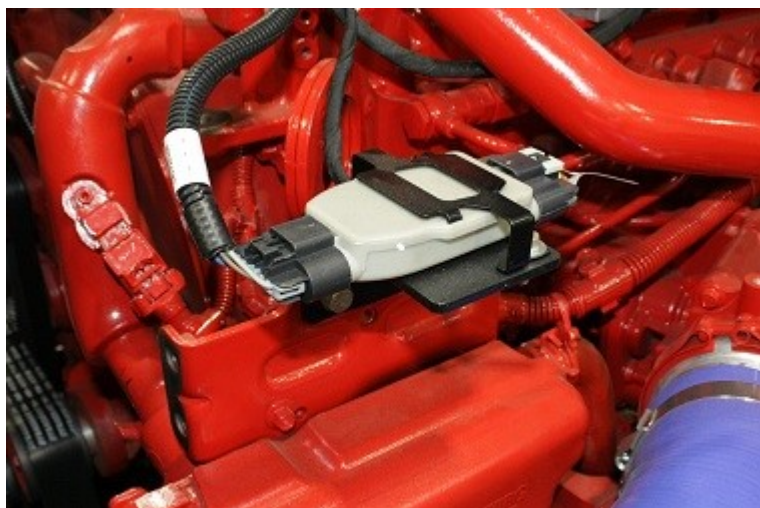
Vehicles equipped with a Cummins X15 engine and a Horton 2 Speed Fan Controller may set a DTC due to fan speed and a communication error broadcasted on the communication bus. This error may result in the fan drive remaining activated until the DTC is cleared, or until the vehicle power is cycled On and Off.

1. Locate the fan controller on the engine.
2. Remove the two electrical connectors on each end.
3. Remove the two 10mm bolts from the bracket holding the controller and remove the controller.
4. Reinstall the new controller, ensuring each end of the controller matches each electrical plug and then reinstall the bracket and the two 10mm bolts.
5. Plug the electrical connectors to the appropriate end of the controller.
