Articles Contained in this Issue

07 Diagnosing Network, U - Codes

07 Parasitic Draw Testing, A Different Approach

15 Auto Start Stop inoperative or Automatically Disabled at Engine On

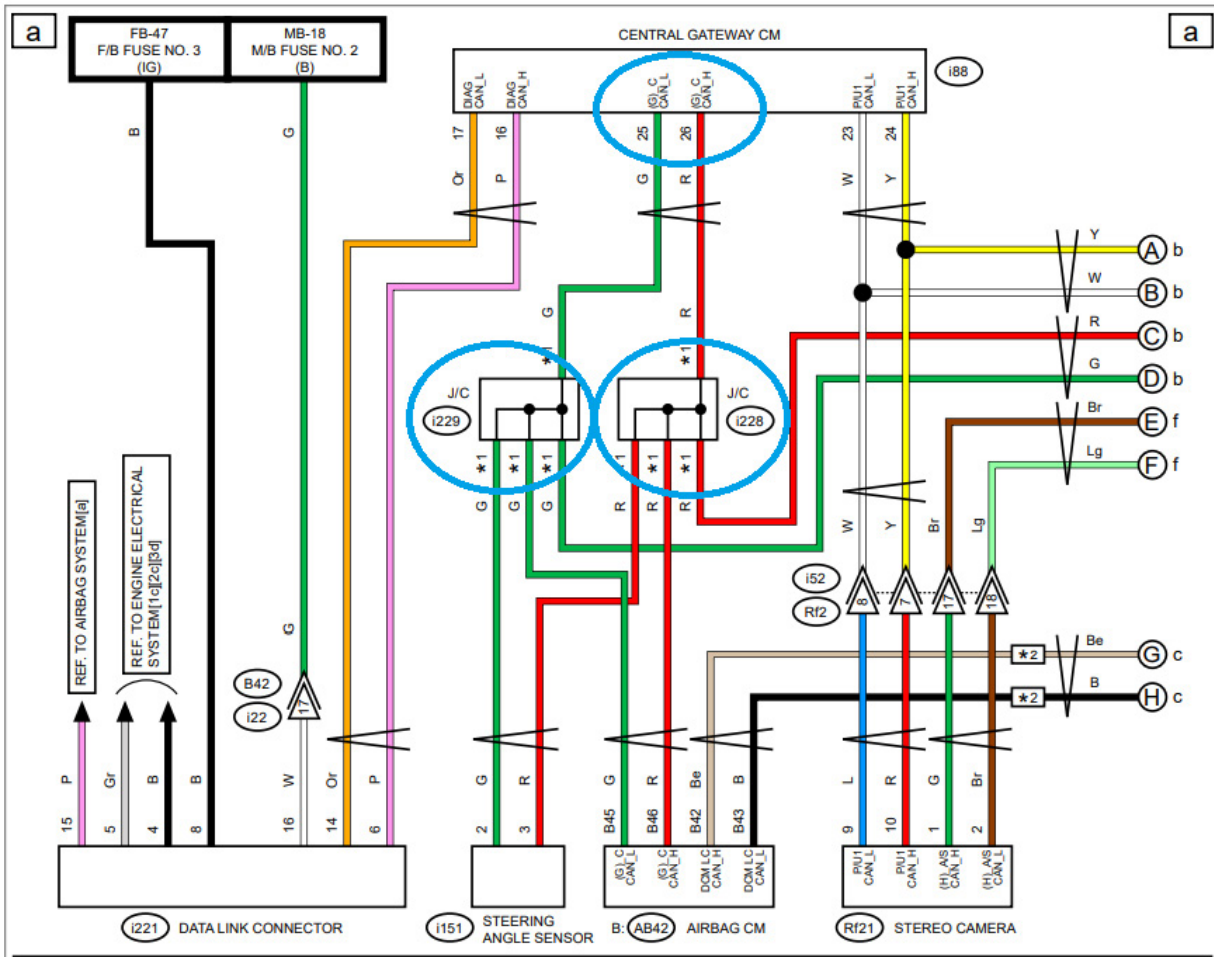
U0127 is common in the meter, and gateway.
 U0151 is common in the meter, EGI, and gateway.
 U0126 is common in the eyesight and gateway.
 U0131 and U0128 are only found in the gateway.

Referring to the wiring diagram it is determined that the only section of wires that these faults have in common are the connector i88 at the gateway, j/c i228, and i229. These points should be inspected while performing resistanc checks

NOTE: DO NOT CLEAR codes to see what returns. If the problem is intermittent, the codes may not return resulting in diagnosis coming to a halt.

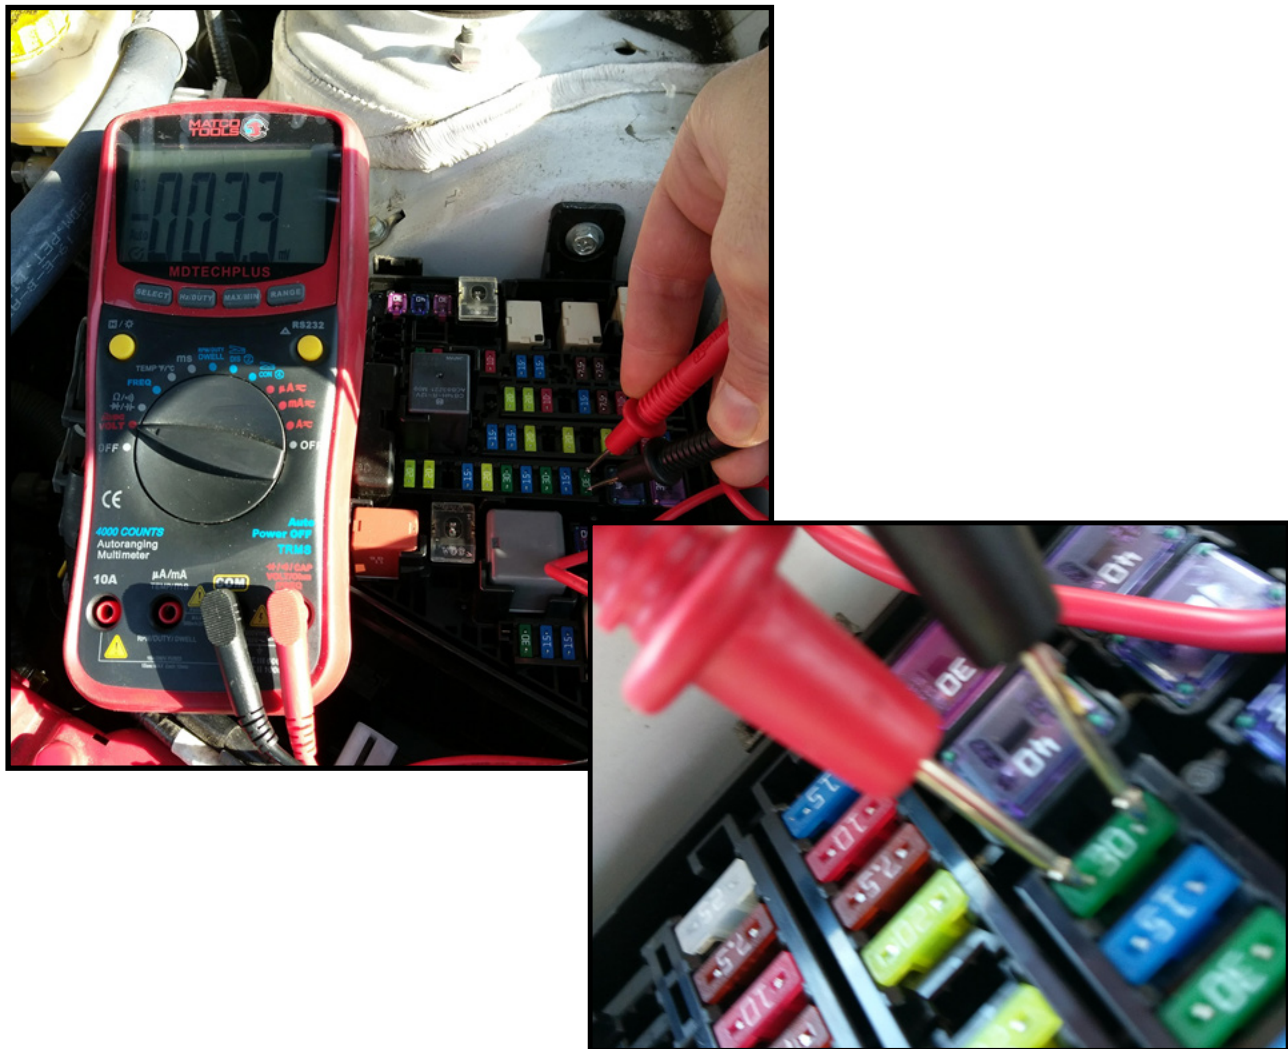
When checking for a parasitic draw, the Technician should be careful and mindful not to wake control modules in the vehicle. This is critical for an accurate diagnosis. Modules may be “awakened” if fuses are pulled and replaced when using an old-style diagnostic method. A more efficient way is to inspect the voltage present across each individual fuse when the parasitic draw is present. The Technician should prepare the vehicle by disabling any door, hood or trunk latch that may need to be opened during the diagnosis. Whenever possible, it is best to have two devices to help diagnose a draw: an amp clamp or a DVOM installed in series with the battery should be used to detect the draw and confirm the draw is present while testing. A second DVOM can be used to test for current flow across the top of a fuse. Place your DVOM into the **mV** setting and check across the top of each fuse individually. Note the measurement and location of the current flow. A millivolt to milliamp conversion chart may be used to get an accurate determination of how much current is passing through a fuse. Refer to the conversion chart for the specific diagnostic tool being used for the most accurate results. If the Technician does not have a conversion chart, the same measurement can be made by setting the meter to **mA**. However, the measurement will not show the actual current draw. The Technician would have to inspect the circuits with the highest **mA** readings. When the source of the draw is found, the Technician should reference the appropriate wiring diagram to individually inspect modules or components without disturbing the integrity of the rest of the circuit.

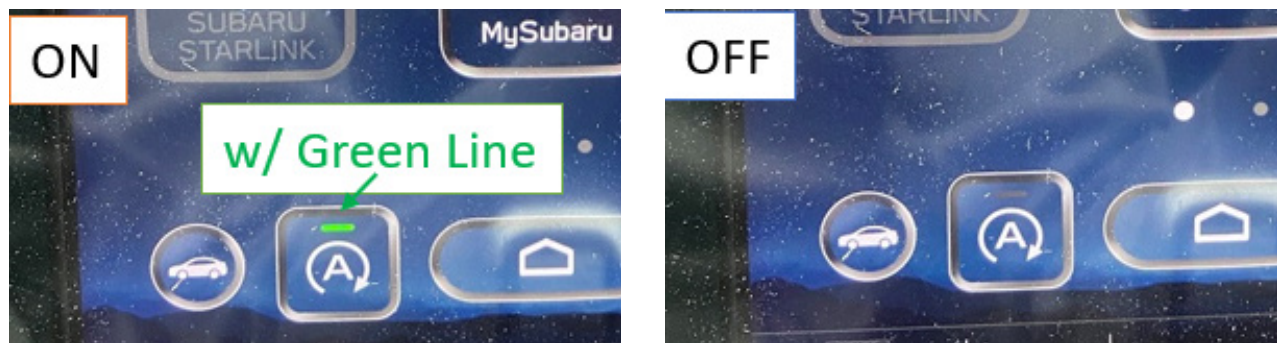
- Turn off Auto Stop once and turn off the engine.
- Start the engine
- Confirm Auto Stop light is Green (see below) and stays Green. This is normal operation.

If the system is equipped with an Eliminator, the light will be Green for a moment and then turn off.

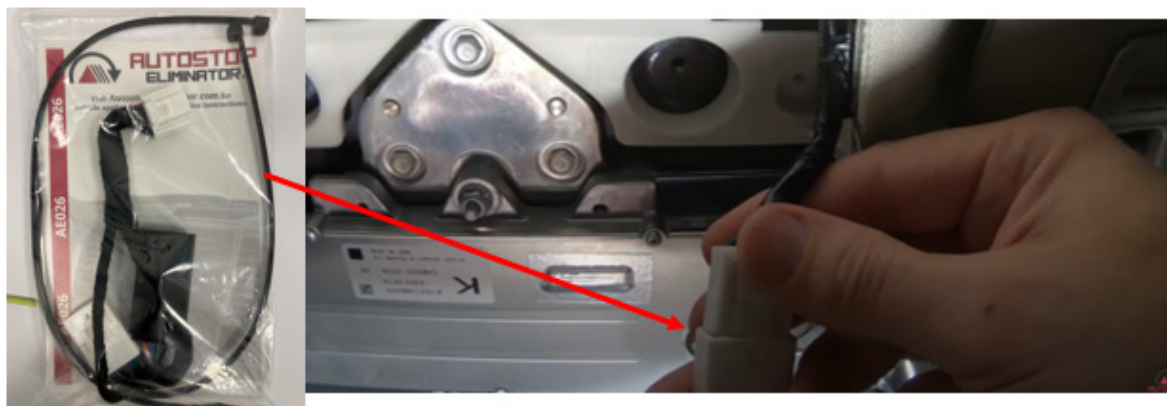
If an Eliminator is suspected to be installed according to the above procedure, an inspection of the EyeSight Camera harness will be necessary. Check to see if there are any extra/unnecessary harnesses around the eyesight connectors with the eyesight camera cover removed.
