## Automated Manual Transmission ( AMT ) - Power Take Off ( PTO ) Active Fault Codes P106E18 (PSID 20 FMI 5) Or P106F18 (PSID 21 FMI 5) PTO Engagement Valve Current Below Threshold

AMT Harness broken PTO wires

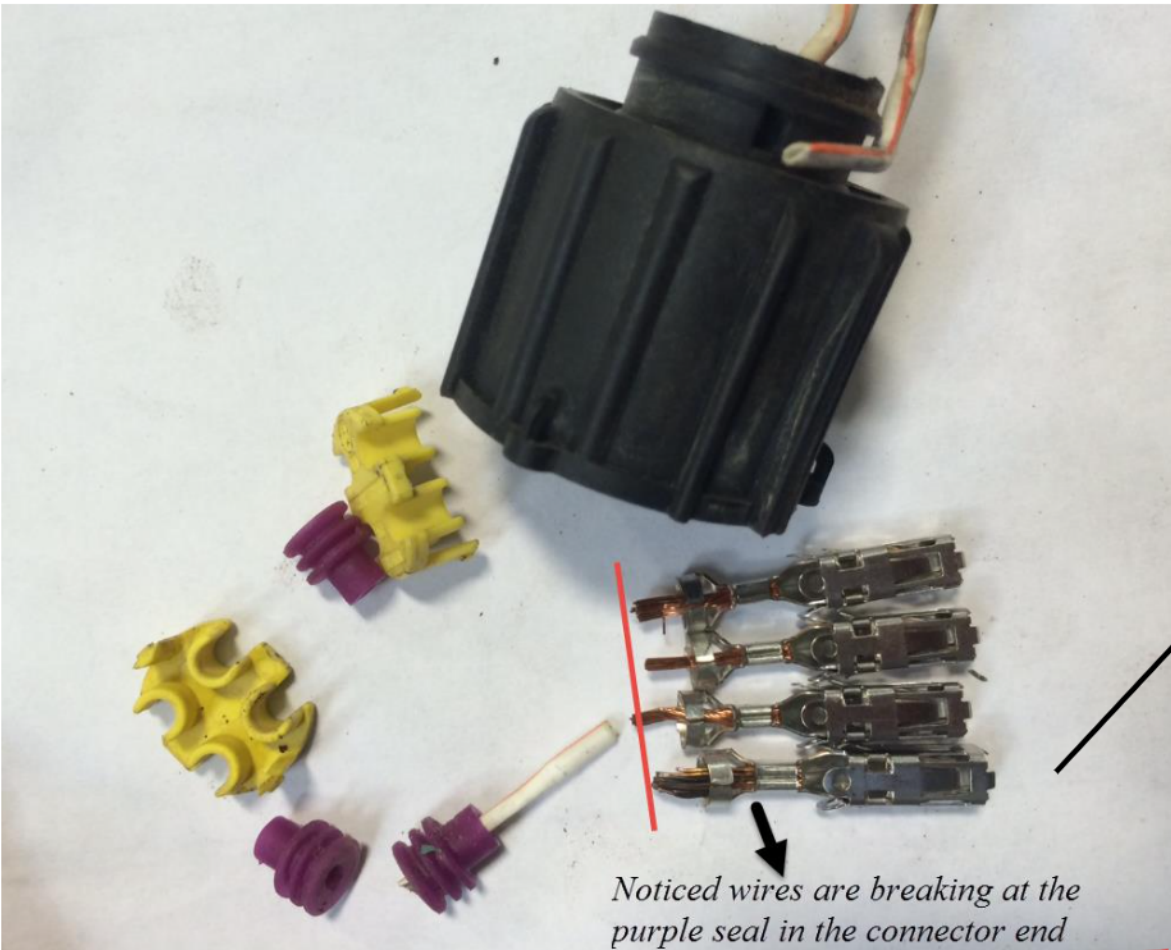
The connector/crimping shown in the pictures shows the wires are cut in the same location. Possible vibration in the wiring (design of the connectors??)

*Noticed wires are breaking at the purple seal in the connector end*

When either of the active faults P106E18 ( PSID 20 FMI 5 ) or P106F18 ( PSID 21 FMI 5 ) are found check the wiring at the PTO solenoids mounted on the back of the transmission. Pull on the wires where they go into the connectors. Replace the harness if a broken wire is found. Repairing the harness with heavier gauge wire does not help.

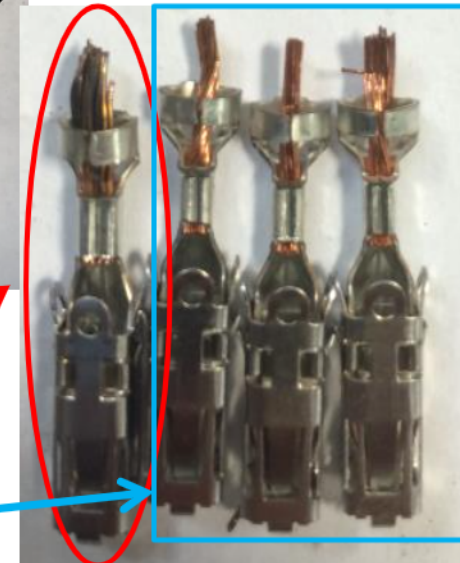
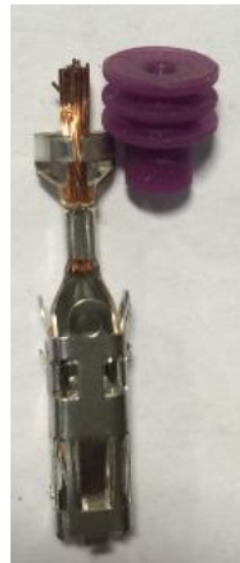
One had been repaired by the dealer with a heavier gauge wire and broken in the same location as the production wires
