## Volvo Chassis - I-Shift Transmission Fails Calibration After Installation Of The Shift Cover

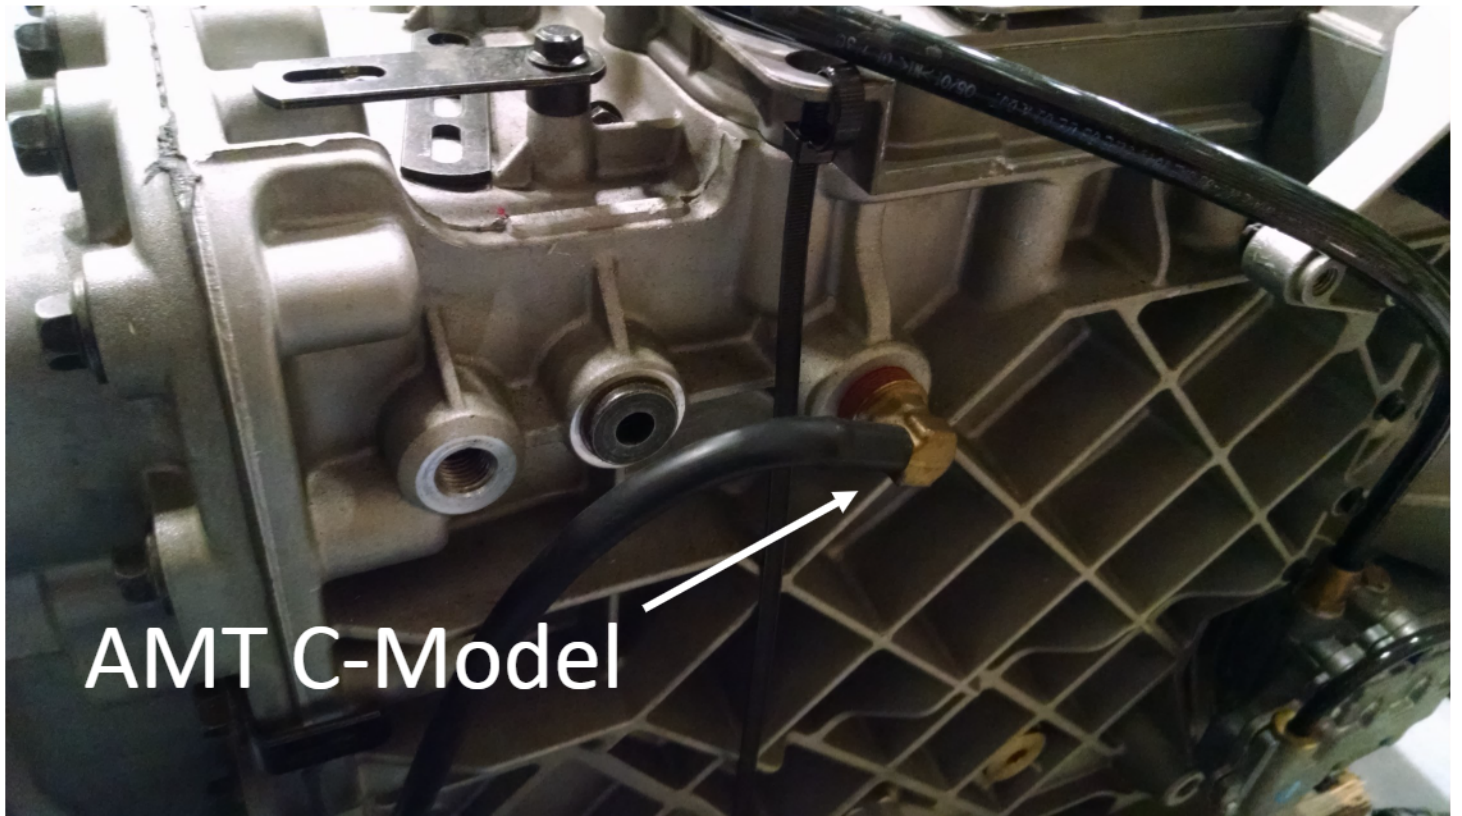
AMT C-Model

A failed calibration after the Volvo I-Shift transmission shift cover has been installed could be related to improper positioning of the range control rod during assembly. To physically check to assure during assembly the positioning is correct there is a threaded hole approximately 1 inch in diameter on the upper right side of the transmission main box case. This hole will have a fitting with a vent hose attached if it is a "C " model transmission. If it is a "D" model transmission it will have a treaded plug. Click [here](#). Removal of the fitting or plug will allow you to see the positioning of the range control rod [here](#) to assure it is correctly positioned.
