Trucks Equipped With A Cummins Engine - Engine Preheat Icon Does Not Illuminate In The Instrument Cluster (IC) During Engine Pre-heat (Intake Air Heater) Operation - Vehicles With 2018 **Instrument Cluster Update, Model Year 2018 And** Newer

System Date And Time, Information; Diagnostic Tool (J-Pro, Premium Tech Tool (PTT)) Displays **Incorrect Timestamp For Diagnostic Trouble Code** (DTC) / Fault Code Occurrences, Possible Data **Link Codes Present - US07 And Newer Emissions, Common Mod**

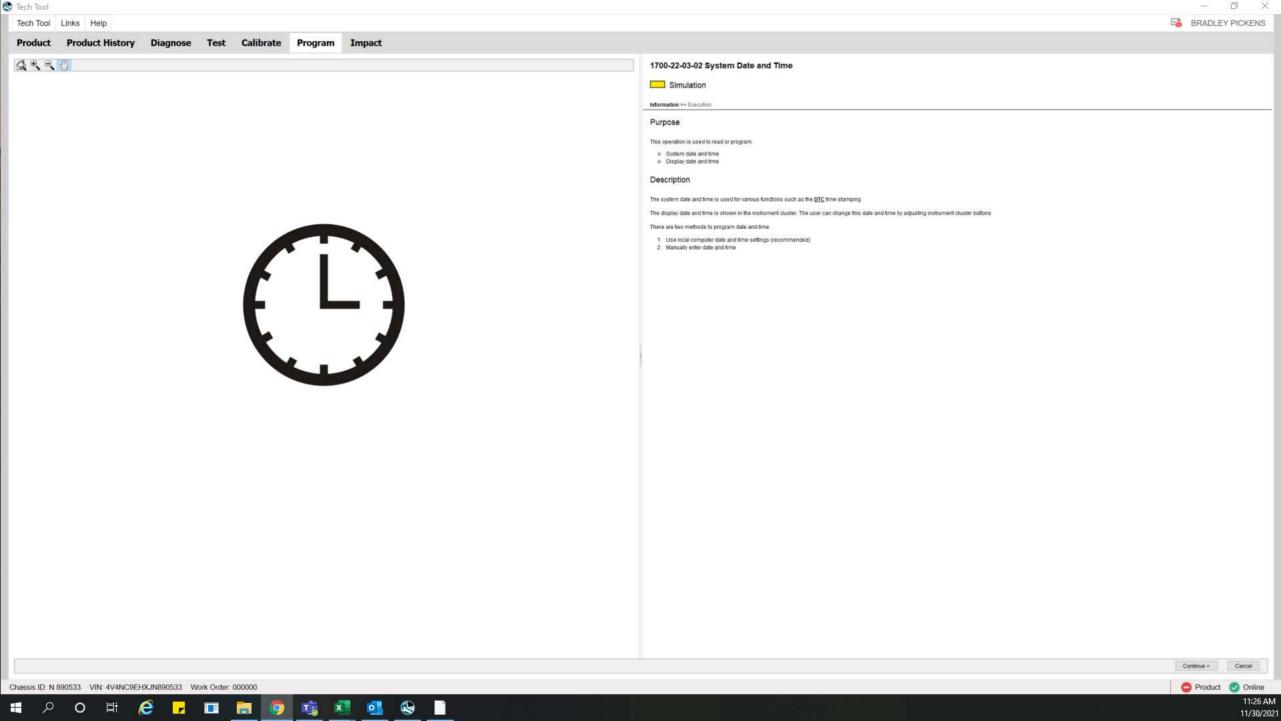
If the Preheat Icon does not illuminate while Engine Preheat is active as shown below:

A. Update Instrument Cluster Software (SW) to enable the parameter.

- 1. In Premium Tech Tool (PTT), run Operation 1700-22-03-06 Accessory Kit. The operation can be found under the Program tab.
- 2. When prompted, enter Accessory Kit Number 85153771.
- 3. Press the Program button in the lower right-hand corner of the screen.
- **4.** Allow the programming operation to complete.
- B. Set Vehicle (System) Date And Time.
- 1. Run PTT Operation 1700-22-03-02 System Date and Time. The operation can be found under the Program tab.
- 2. More information can be found in CBR Solution K11533602.

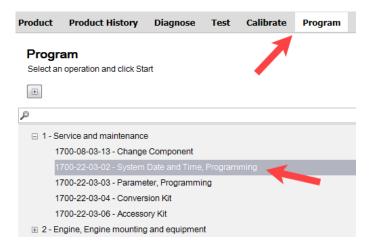
Incorrect time and date timestamps are caused when the Vehicle Date and Time are not set or set incorrectly. The Vehicle Date and Time are stored in the Instrument Cluster (MID 140) and are separate from the Display Date and Time, which is visible on the Driver Information Display (DID).

Multiple modules have internal clocks that compare values with the Vehicle value. Incorrect Vehicle Date and Time can result in conflicts between Control Modules, resulting in possible faults/codes. Examples are: Data Link DTCs, P2080, P2094 and P242B

- A. Program the System Date and Time
 - For Pre-OBD (US07 and US10 Emissions, Model Years 2008 to 2013 with a 9-pin diagnostic connector):
 - 1. Run Operation 1700-22-03-02 System Date and Time, Programming.

- Note: If the computer date and time is used (preferred method to manual entry), ensure that computer date and time are correct
- For OBD (US10+OBD13 Emissions, Model Years 2014 and newer with a 16-pin diagnostic connector:
 - 1. Run Operation 1700-22-03-02 System Date and Time.
