## Volvo Chassis - Equipped With A Cummins Engine - Cummins Fuel Pump Timing Correction to Reduce Engine Noise; Drone Noise at 1500 RPM and Increases With Engine Load - US10 And Newer Emissions, Common Model Year 2014 And Newer

Technical Service Bulletin:  
TSB170124

Fuel Pump Timing Correction to Reduce Engine Noise

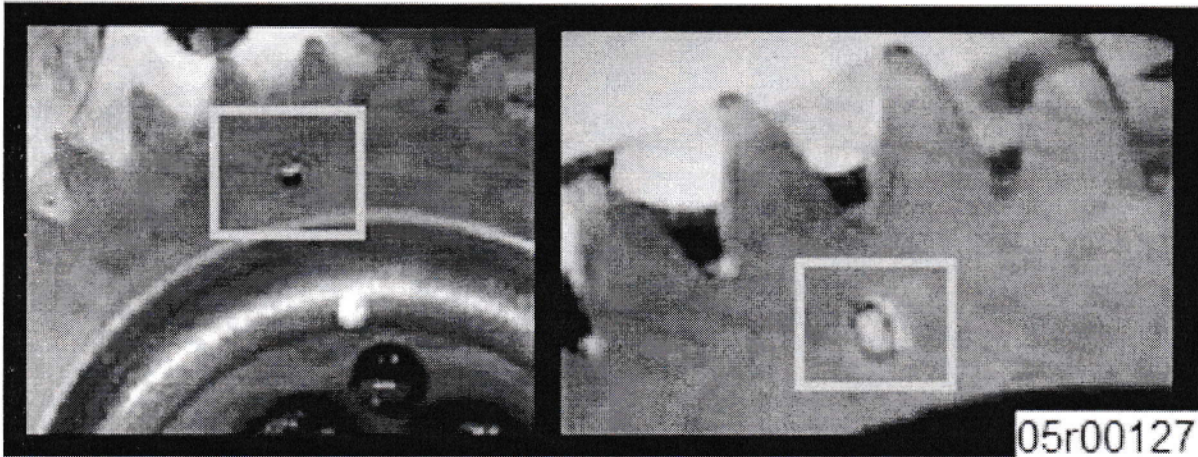
Figure 1, Fuel Pump Timing Mark Examples.

- Pin crankshaft. See corresponding Service Manual. Reference Procedure 001-088 in Section 1.
- Remove high pressure fuel pump. See corresponding Service Manual. Reference Procedure 005-116 in Section 5.
- Clean front face of fuel pump gear of excess oil.
- Locate fuel pump timing mark stamped on front face of fuel pump gear. Fuel pump timing mark is either a “0” or “•” See Figure 1 below.

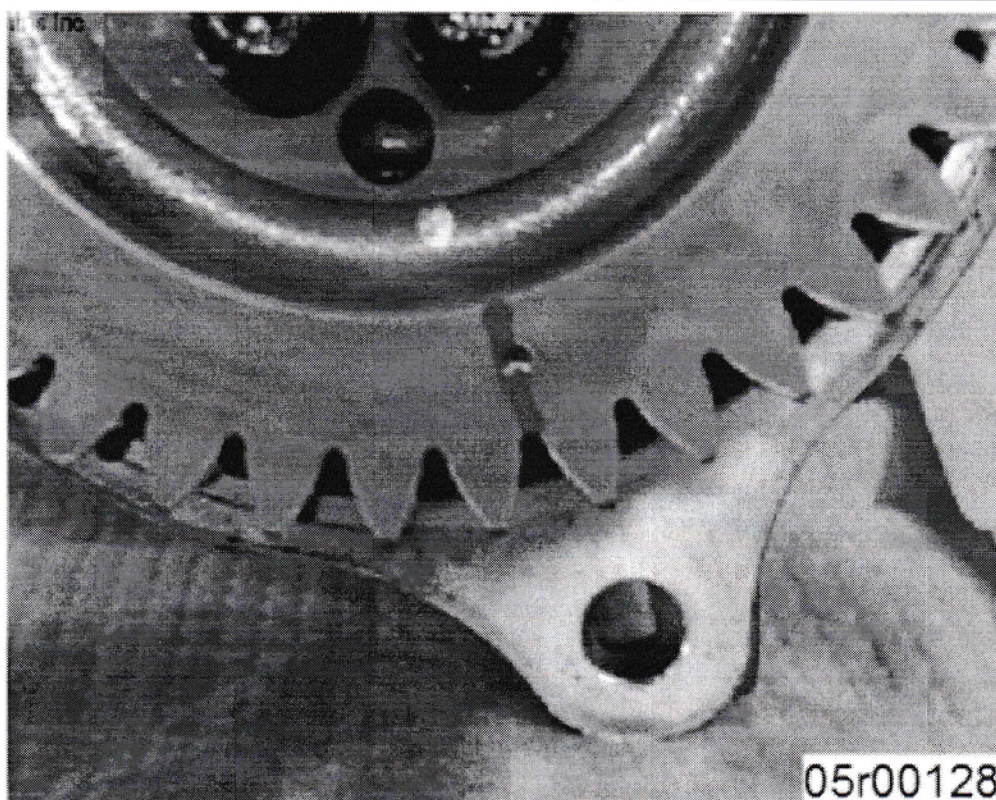
Figure 2, Line over Fuel Pump Gear Timing Mark to Outer Edge of Fuel Pump Gear.

- Using a paint marker, draw a line over fuel pump gear timing mark to outer edge of fuel pump gear. See Figure 2 below.

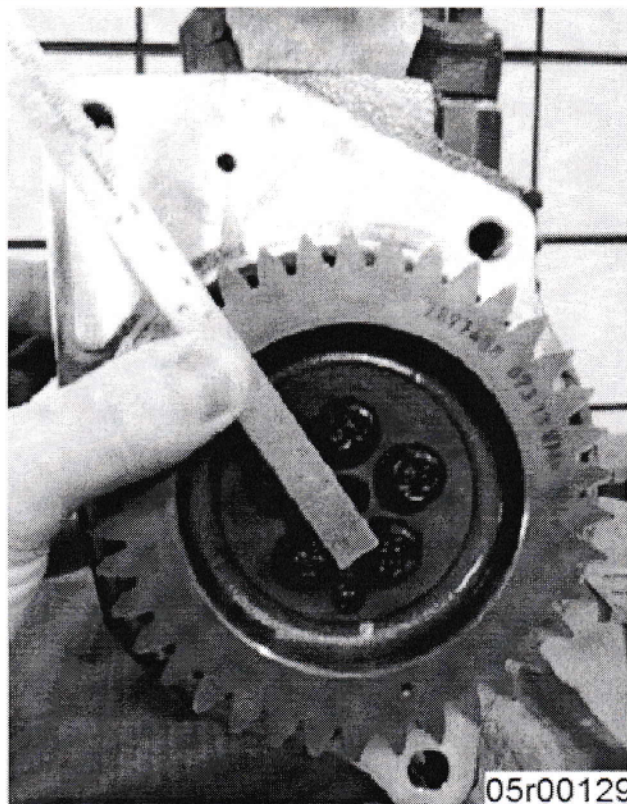
Figure 3, Fuel Pump Camshaft Center Line and Mounting Hole Center Line Alignment.

- Align a straight edge or ruler between center-line of fuel pump camshaft and center of upper left fuel pump mounting hole. See Figure 3 below.

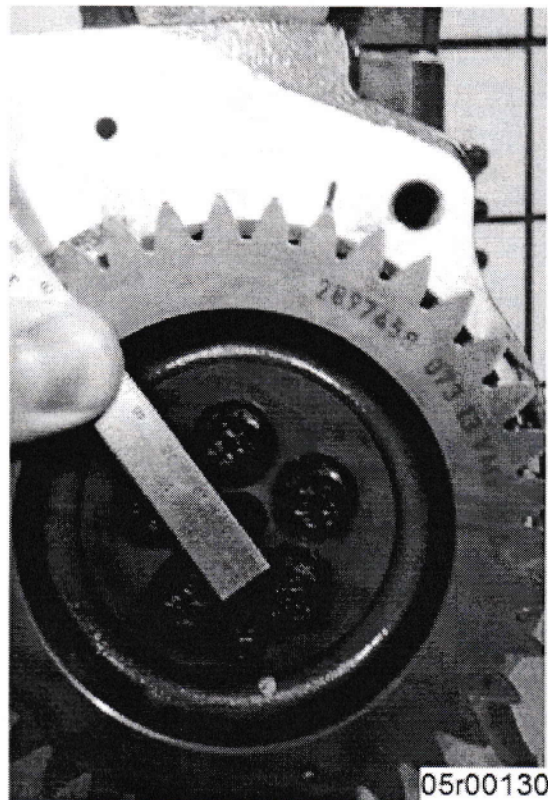
Figure 4, Mark Fuel Pump Housing (ISX15 CM2350 X101 and X15 CM2350 X114B).

- Mark fuel pump housing (ISX15 CM2350 X101 and X15 CM2350 X114B **only**):
  - Count six complete fuel pump gear teeth **clockwise** from straight edge tool and mark corresponding location on fuel pump housing.
  - Example in Figure 4 below is an approximate location. All marks **must** be made by counting gear teeth and **not** by matching Figure 4.

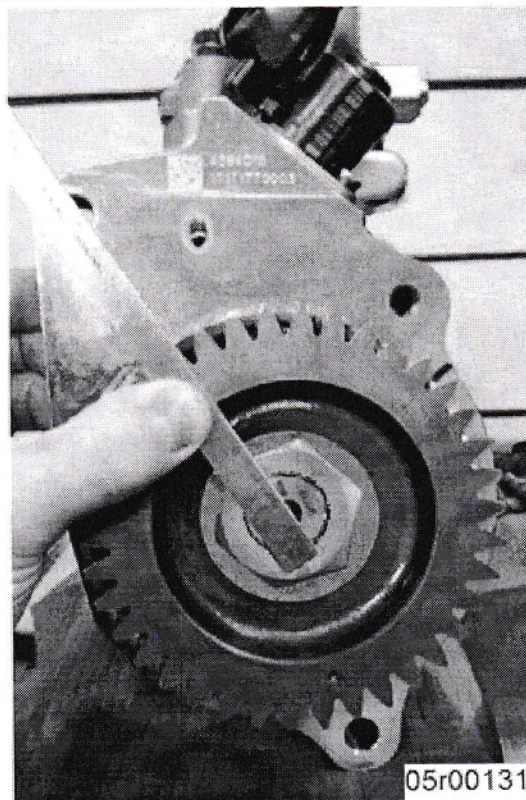
Figure 5, Mark Fuel Pump Housing (X15 CM2350 X116B).

- Mark fuel pump housing (X15 CM2350 X116B **only**):
  - Count eight complete fuel pump gear teeth **clockwise** from straight edge tool and mark corresponding location on fuel pump housing. See Figure 5 below.
  - Example below in Figure 5 is an approximate location. All marks **must** be made by counting gear teeth and **not** by matching Figure 5.

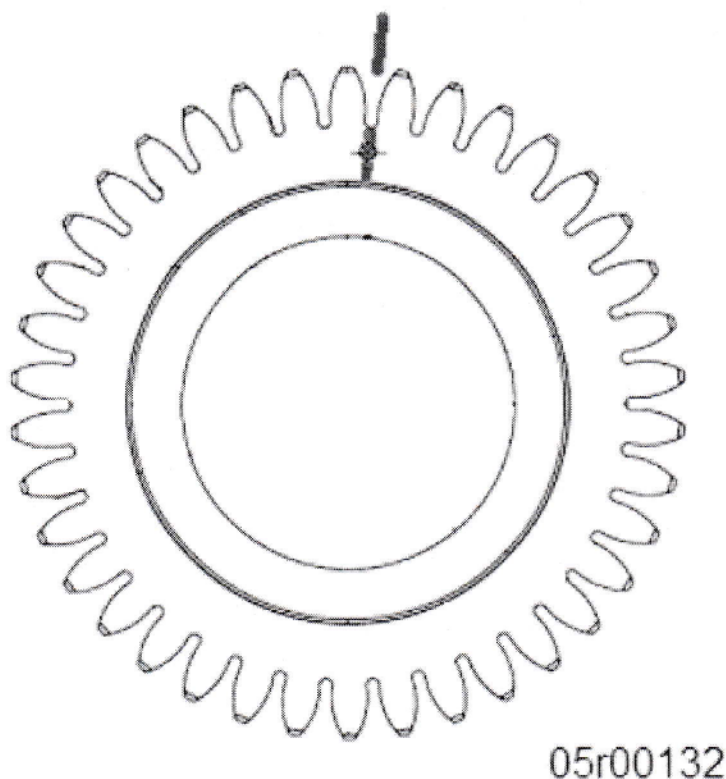
Figure 6, Align Marks on Fuel Pump Gear and Fuel Pump Housing.

- Rotate fuel pump gear until painted line over timing mark aligns with mark on fuel pump housing. See Figure 6 below.
