## Automated Manual Transmission ( AMT ) Bearing And Gear Shaft Inspection

Codes associated with this complaint:

- P1071- Split Engagement System, FTB 96 Unintentional disengagement of direct split
- P1057- Main Shaft Speed Sensor, FTB 21 Data valid but below operational range

Loss of main shaft pre-load from a spigot bearing failure

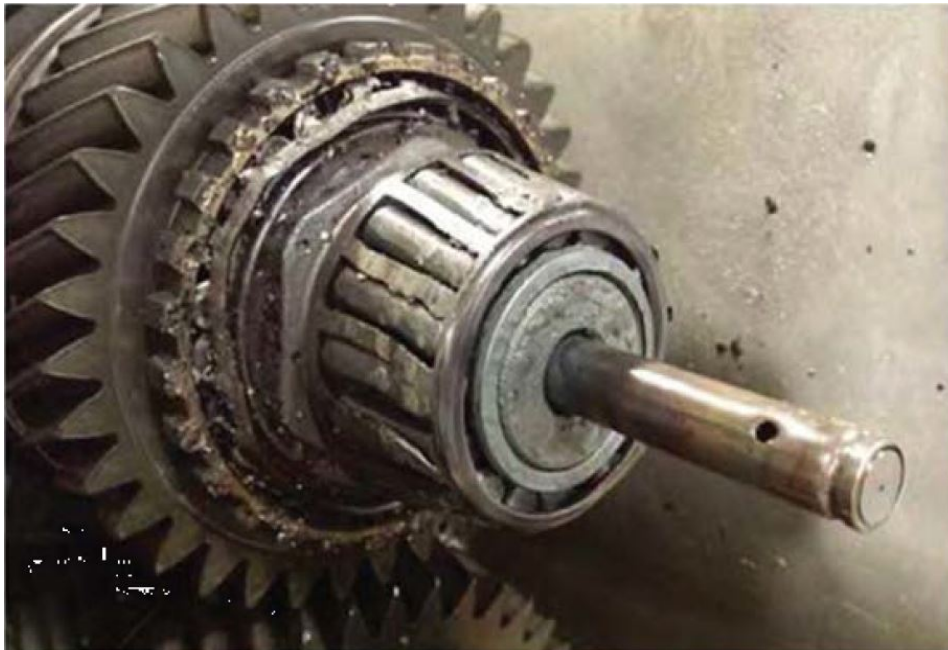
Towing Related Failure (Image 1)

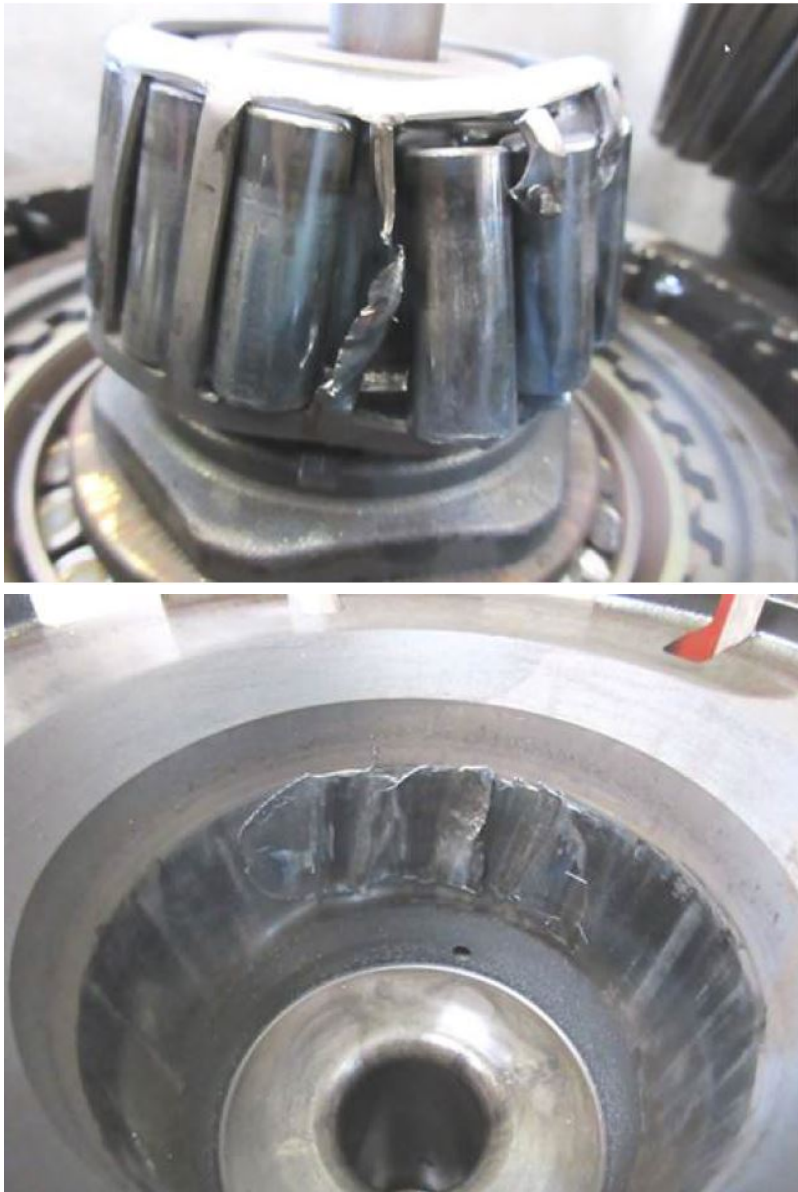
**Towing Related Failure (Image 2)**

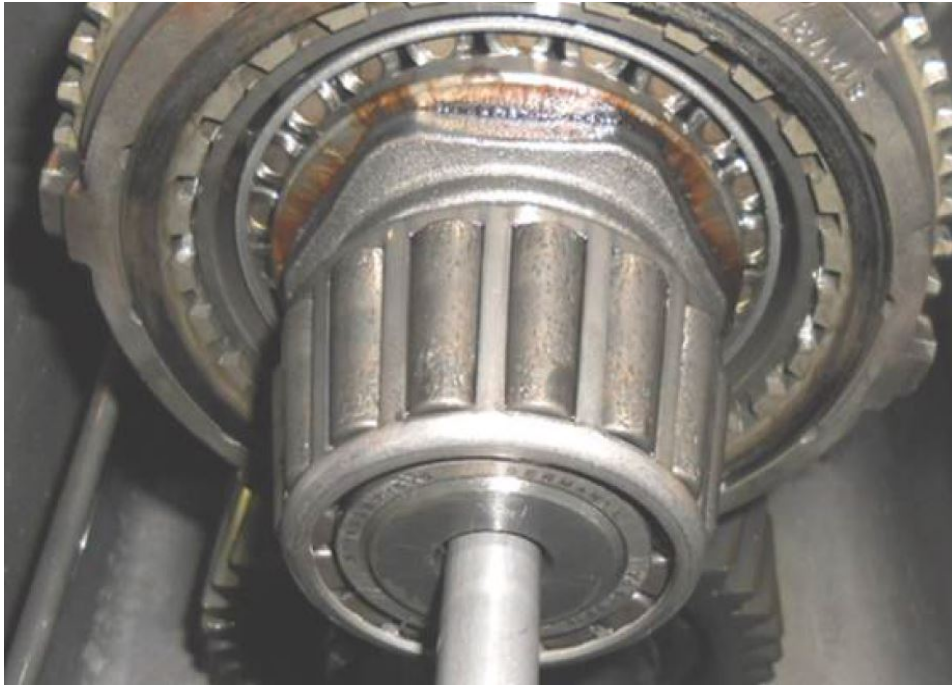
**Spalled bearing failure (Image 3)**

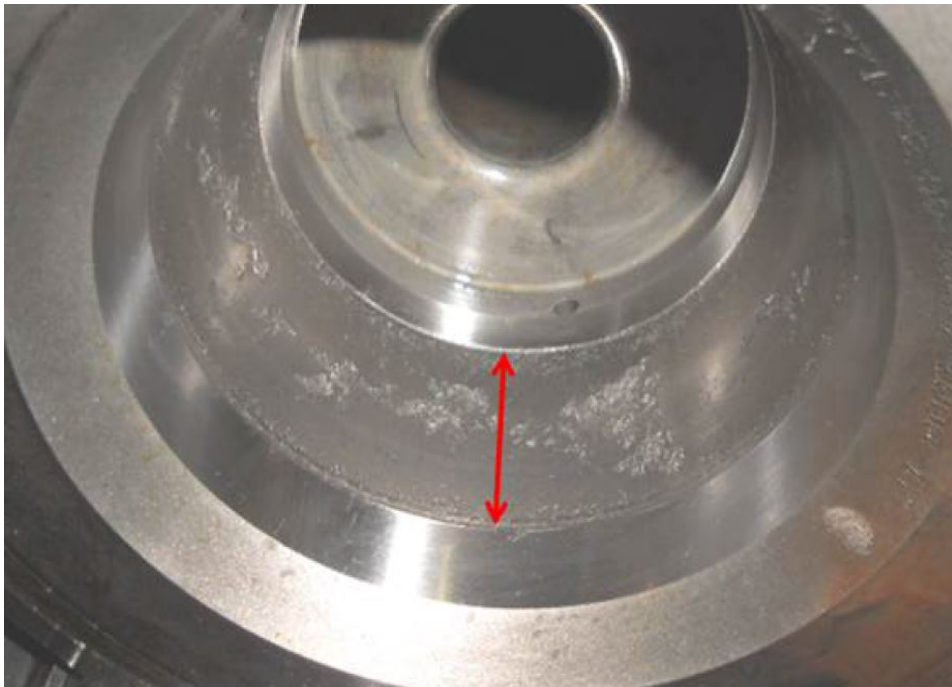
**Spalled bearing race (Image 4)**

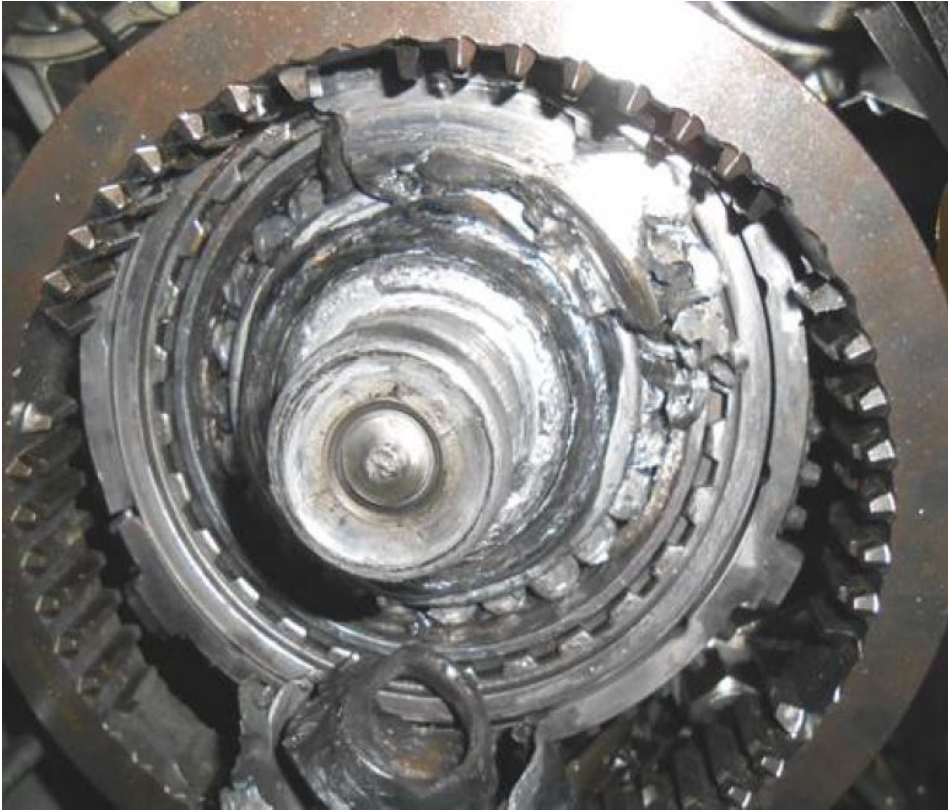
**Spalled Bearing Failure (Image 5)**

**These images (5 & 6) represent a failure that went ignored for some time.**

While the main shaft does not have evidence of heat as in the towing example (image 1), there are additional parts that have been affected:

- Contact with the main shaft nut
- Rollers missing and race worn down
- Oil distribution tube twisted off and closed
- P1 bearing damaged
- Split synchro ring broken

1. The ridge in the input shaft. This is similar to what is seen in the spalled spigot bearing failure **image 3**.
2. The DTC readout, as in the example below. The vehicle clock is incorrect however you can assume that the "Last Occurrence" has to be close to the readout day. In this example you can see that there had been main shaft codes for ~2 mo and split shift codes for ~3mo

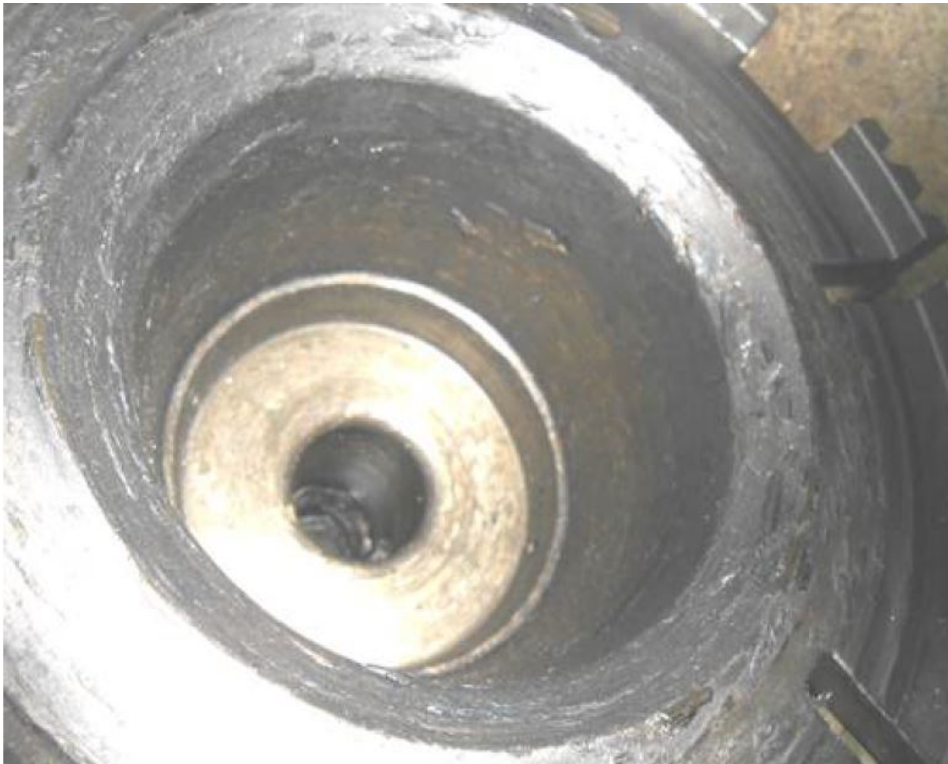
**Spalled Bearing Race (Image 6)**
