## Volvo Chassis - I-Shift Transmission - Diagnostic Trouble Code (DTC) P1060 74 / PPID 50 FMI 11 Clutch Protection Active - Message Being Seen In The Cluster

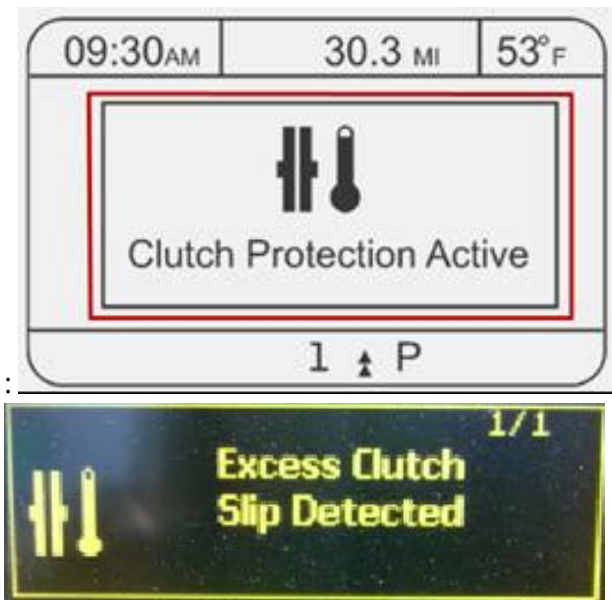
- The I-Shift/mDRIVE is an automated manual transmission and not a traditional automatic.
- This transmission uses a push-type clutch and not a torque converter found in an automatic transmission
- The code setting conditions are Clutch slip more than 8.0 seconds with vehicle movement less than 32 in (0.8m) (example: hill holding event)
- Holding the vehicle on an incline or raising the engine rpm waiting at a traffic light or intersection without the vehicle moving will cause the clutch to slip unnecessarily and set this code
- Investigation has revealed there are no codes being set outside of the code setting conditions
- Additional information for the driver pertaining to these codes can be found in the operators guide

**If the IC is programmed after W16XX or the truck is built after W16XX the new message will apply. This does not apply to trucks built prior to OBD13. The new message is 'Excess Clutch Slip Detected'**

- The message displayed in the instrument cluster is meant to alert the operator and discourage this activity
- The vehicle should not be brought into the shop for this code alone, only if associated with other clutch control codes

Live UI should be no time spent troubleshooting this code as this is meant for the operator only
