## Diagnostic Trouble Code (DTC) P0201 To P0206 FMI 13 - OBD2015 HDE 11 ( Model Year 2016 Truck )

### DTC P0201 FMI 13 to P0206 FMI 13 (Injectors 1 through 6 Open Circuit)

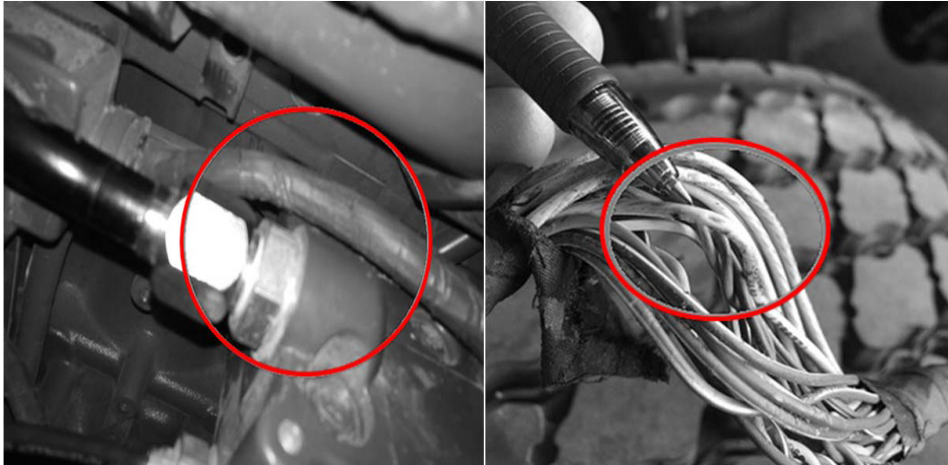
The engine harness in the air compressor area may not be supported correctly and may have made contact with the air compressor. When these faults are logging, look in this area first. Do not check under the valve cover until this area has been inspected. A service publication will be released to address this issue.
