## Mack LR Models - FSB 810-004, Back Of Cab Crack, Repair

## Back Of Cab Crack, Repair LR

### FSB 810-004, Back of Cab Crack, Repair

(July 2020)

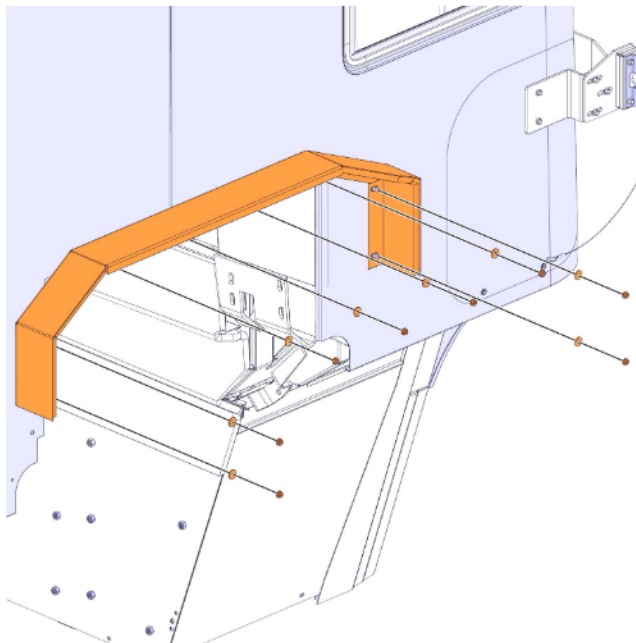
T8159766

Certain Mack LR model trucks may experience crack on the back of cab. Mack Trucks determine to replace the existing panel kit of engine cover with new panel kit.

- 9 Drill a stop hole at the end of crack. Weld and repair the crack on the back of cab.
