2022 Taycan – Ensuring Porsche Connect Functionality During Vehicle Handover

Models	Model Year	Model Type	VIN Range	Vehicle-Specific Equipment
Taycan	2022	Y1A, Y1B	N/A	N/A

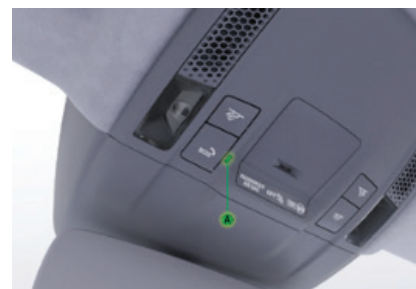
Figure 1

- b. Check the status of the indicator light for the SOS Call button (Figure 1, A). It is likely flashing red due to further required steps
5. Perform all remaining vehicle handover selections

- i. Diagnostics --> OTA-FC --> Maintenance/Repairs --> ORU-Reset
 - d. Check the eSIM connection status again via the PCM (above step 8.a.i)
 - i. The Cellular network should change to Verizon, indicating eSIM R&P completion. This may take approximately 5 minutes to complete. Once complete, the SOS light in the overhead console should be green.
