Symptom - Crackling Noise from B-Pillar on Cabriolet Vehicles: Subsequent Work on Body at the B-Pillar (SY 168/21)

Vehicle Type: **911 Carrera Cabriolet (992) / 911 Carrera S Cabriolet (992) / 911 Carrera 4 Cabriolet (992) / 911 Carrera 4S Cabriolet (992) / 911 Carrera Turbo Cabriolet (992) / 911 Carrera Turbo S Cabriolet (992) / 911 Carrera GTS Cabriolet (992)**

Model Year: **As of 2020**

Concerns: **B-pillar reinforcement**

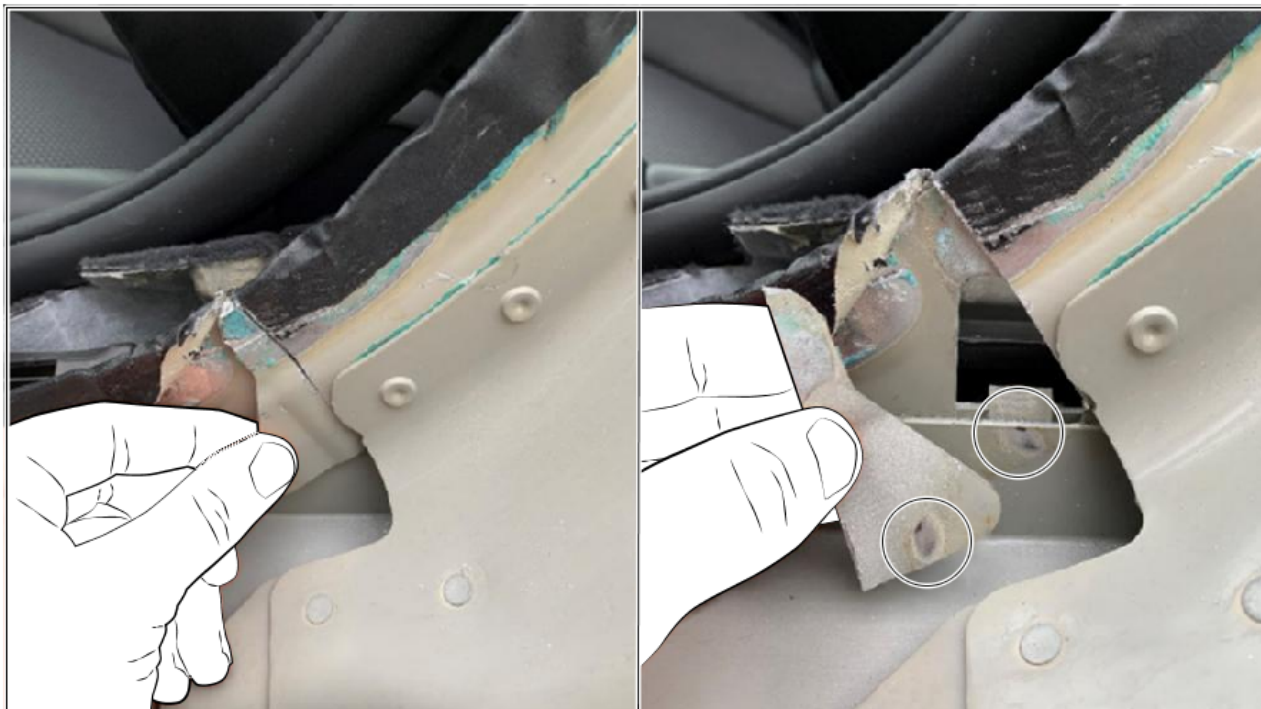
Cause: Crackling noises can be produced through a potential contact point of the various sheet metal panels between the door sill and B-pillar.

Example of sheet metal contact on unpainted bodyshell.

For better illustration of the contact point, this is shown from the opposite side and separately. The subsequent work will be performed from the inside of the vehicle later.

Remedial Action: Deform sheet-metal layers on the side of the vehicle where the customer has complained about the noise using a suitable screwdriver and a targeted hammer blow to prevent contact with the sheet metal and prevent crackling noises.
