JLRTB02059NAS3

**TECHNICAL BULLETIN**

412-01A

Incorrect Operation of Climate Control Air Distribution

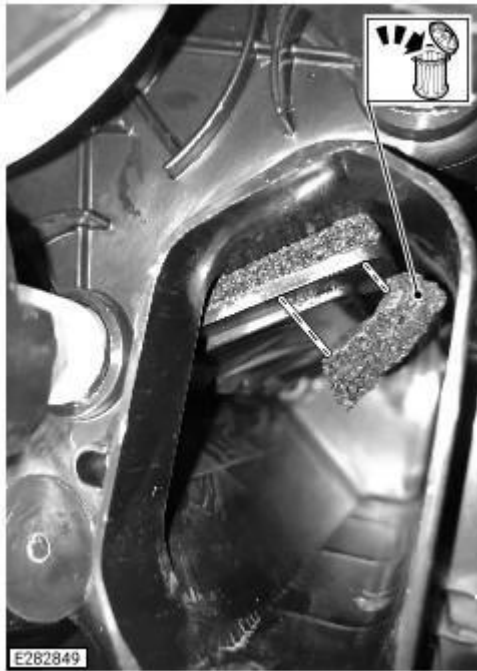
8.

The airflow distribution doors have become locked. In some cases, the foam seals on the back of the distribution doors have become detached and trapped the doors.

Remove and discard any adhesive foam pads that have detached from the left and right distribution doors.

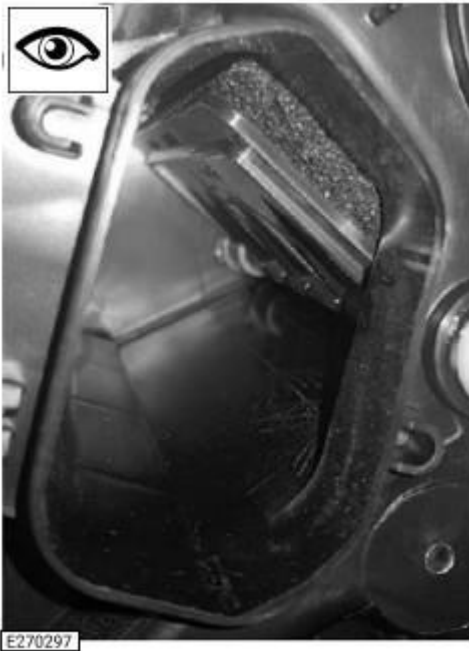
9.

The illustration shows a distribution door in the 'closed/up' position. If a distribution door is in the 'open/down' position, carefully manually close the distribution door.
