Bulletin #: 2129 Part ID: 2003

971 – Fuel Delivery and Suspected Fuel Vapor Lock

Models	Model Year	Model Type	VIN Range	Vehicle-Specific Equipment
Panamera	As of 2017	971	N/A	N/A

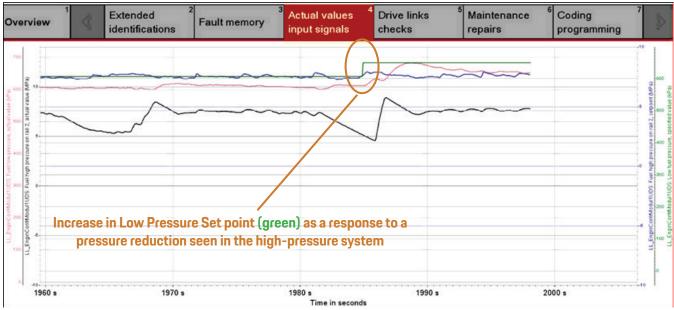
Figure 1 - Fuel Pressure Operation at Idle of a G2.I Configured with V8

Actual: Low-pressure fuel ($\approx 5.5 - 6.5$ bar) Set point: Low-pressure fuel (6 - 6.5 bar) Actual: High-pressure fuel bank (≈ 70 bar at idle) Set point: high-pressure fuel bank 2 (≈ 70 bar at idle)

The plot in Figure 1 illustrates the behavior of the low-pressure circuit as controlled by the DME when significant drops in high-pressure occur (this specific function exists in V8 equipped order types). Specifically, we see the step-change in the low-pressure set point from 6 to 6.5 bar (green) to better supply the high-pressure circuit. The result in this instance is a correction to both the low- and high-pressure fuel systems, as witnessed by their respective actual values. In instances of extreme fuel volatility, vapor lock can otherwise result (see Figure 2). The design countermeasure exhibited in Figure 1 can be helpful, but my not remedy all, highly volatile situations. Figure 1 cites an example of properly functioning high and low pressure fuel circuits. It is important to first diagnose the high- and low-pressure circuits individually, starting with the low-pressure side, to rule out any physical issues with the systems (e.g. a blockage and or a faulty fuel pump).
