**2022 Taycan – Ensuring Porsche Connect Functionality During Vehicle Handover**

Models	Model Year	Model Type	VIN Range	Vehicle-Specific Equipment
Taycan	2022	Y1A, Y1B	N/A	N/A

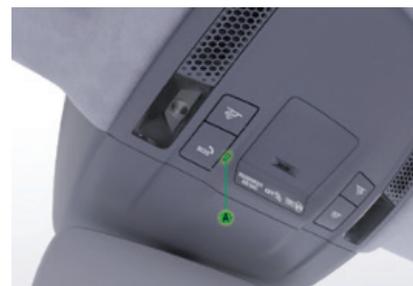
Figure 1

- b. Check the status of the indicator light for the SOS Call button (Figure 1, A). It is likely flashing red due to further required steps
5. Perform all remaining vehicle handover selections

6. Review the Vehicle Handover completion screen. The SOS light in the overhead console is probably flashing red.
7. Exit the vehicle handover screen; a Vehicle Analysis Log (VAL) will be required upon completion of the Vehicle Handover, before customer delivery.

- i. Diagnostics --> OTA-FC --> Maintenance/Repairs --> ORU-Reset
  - e. Check the eSIM connection status again via the PCM (above step 8.a.i)
    - i. The Cellular network should change to Verizon, indicating eSIM R&P completion. This may take approximately 5 minutes to complete. Once complete, the SOS light in the overhead console should be green.
