Technical product information

Topic	Vehicle vibration/humming at idle - Active Engine Mount leak
Market area	Russische Föderation (5RU),Australia E04 Bentley rest Asia and Australia (6E04),China 796 VW Import Comp. Ltd (Vico), Beijing (6796),Germany E02 Bentley rest Europe (6E02),Japan E03 Bentley Japan (6E03),Korea, (South) E08 Bentley South Korea (6E08),United Arab Emirates E06 Bentley Middle East and Africa (6E06),United Kingdom E01 Bentley UK (6E01),United States E05 Bentley USA and rest America (6E05)
Brand	Bentley
Transaction No.	2064964/1
Level	EH
Status	Approval
Release date

New Continental GT/GTC and New Flying Spur - W12 engine only

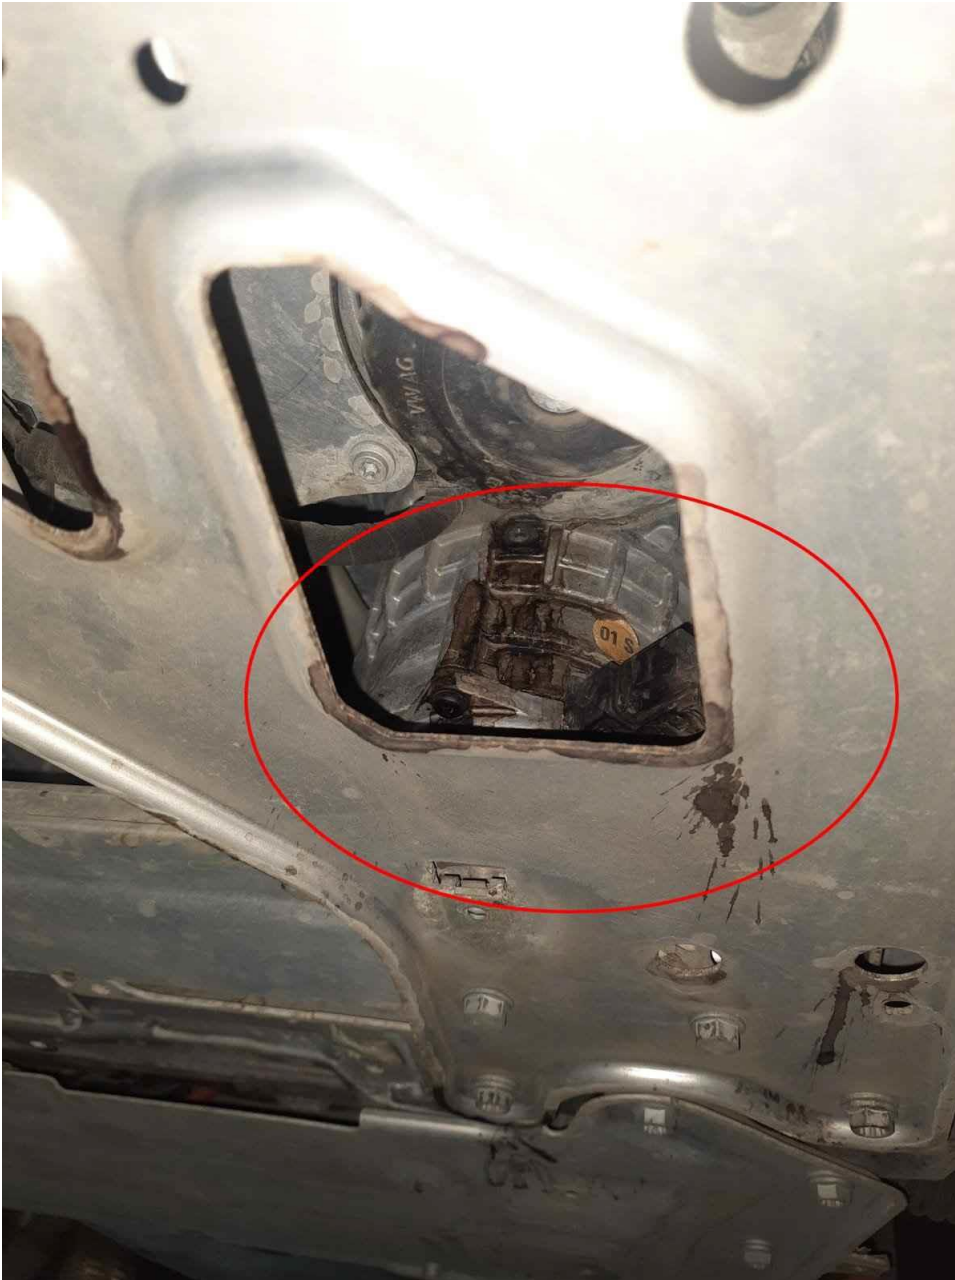
Figure 1

- Left and/or right hand Active Engine Mount leaking oil (see the examples shown in Figures 1,2 and 3)

This particular issue is only evident on W12 engine installations, the symptoms are mostly evident at idle

1) Refer to Rep.Gr.10 Engine mounts -To remove and fit - Replace the left and right hand Active Engine Mounts
