Technical product information

Topic	Rotating Display - Fault Diagnosis
Market area	Bentley: worldwide (2WBE),Hongkong-Macau (5HK)
Brand	Bentley
Transaction No.	2055580/8
Level	EH
Status	Approval
Release date

New Continental GT

Various rotating display operational complaints or noises.

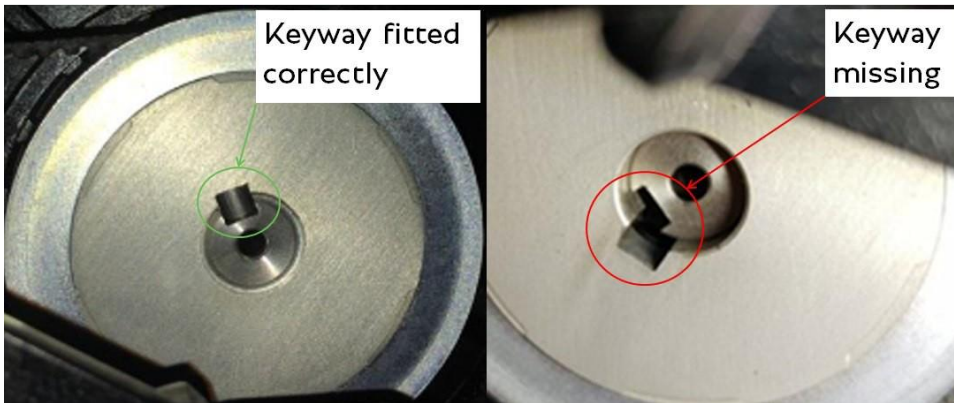
Figure 1

Check pulley wheel for looseness and ensure the keyway is present and fitted correctly (Figure 1)

If either defect is present raise a DISS technical query with photos attached, do not follow any more steps at this point

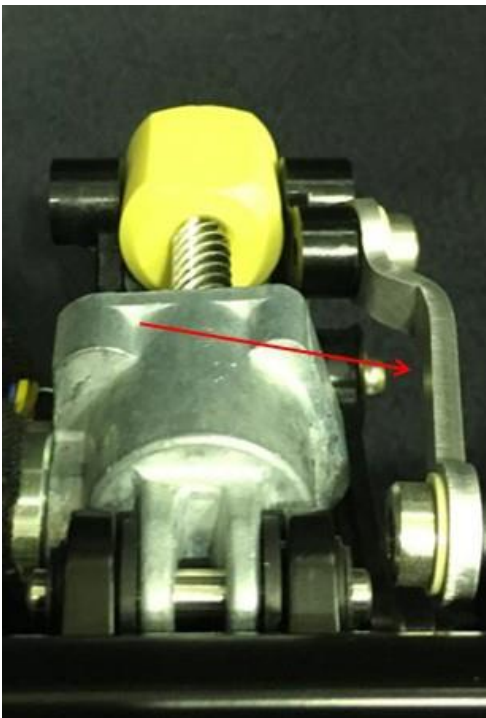
Figure 2

Check link bar for deformation (Figure 2)

If the link bar is deformed or bent, remove the link bar and attempt to straighten, then refit the link bar. Refit the rotating display to a state that it can be tested then carry out re-initialisation and retest. Should this not be successful raise a DISS technical query with photos attached, do not follow any more steps at this point.

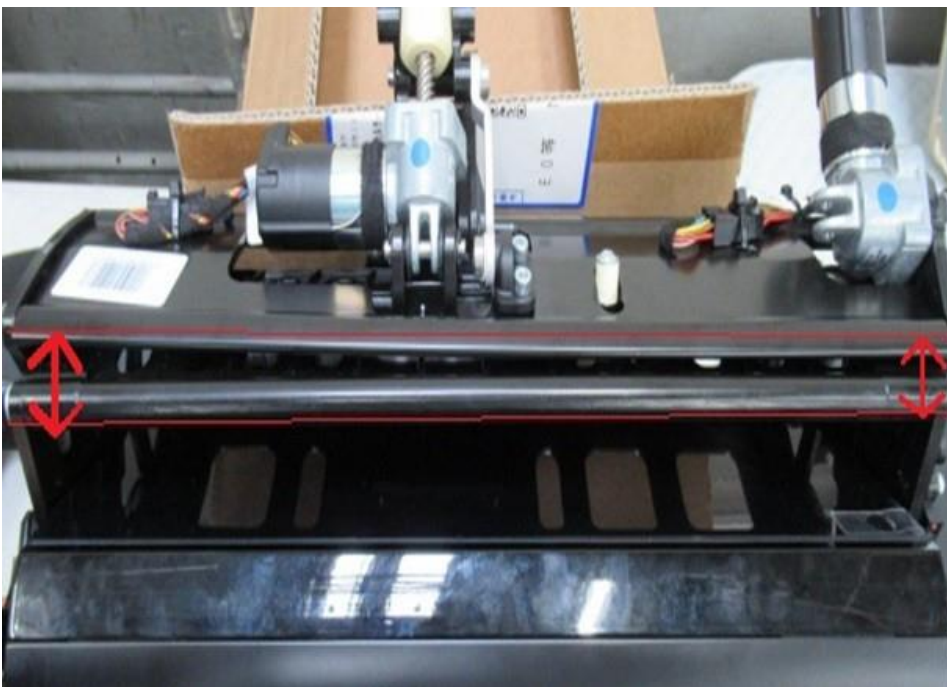
Figure 4

Check the alignment of inner to outer mechanism as shown (Figure 4)

If the mechanism is out of alignment raise a DISS technical query with photos attached, do not follow any more steps at this point.

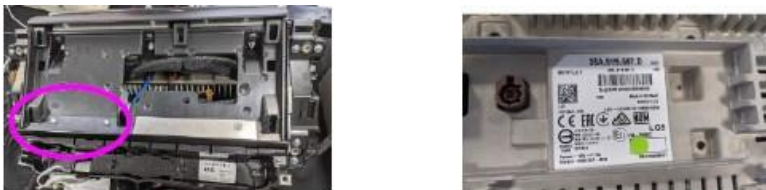
Figure 8

Check for presence of the balance weight and screen revision levels and capture images of both (Figure 8)

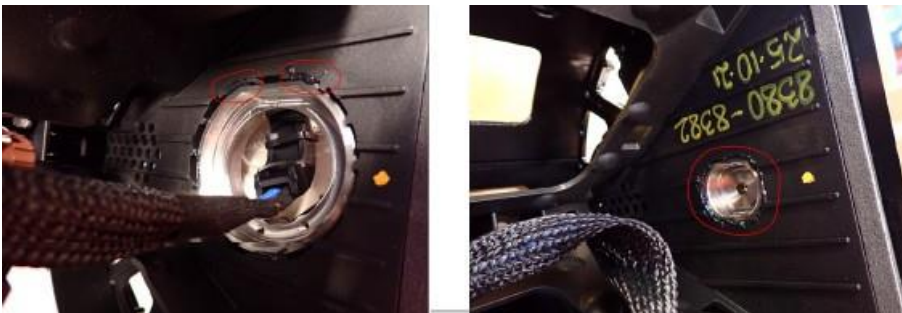
Figure 9

13) Check for bonding/adhesive of BRD bearings and capture images to confirm (Figure 9)

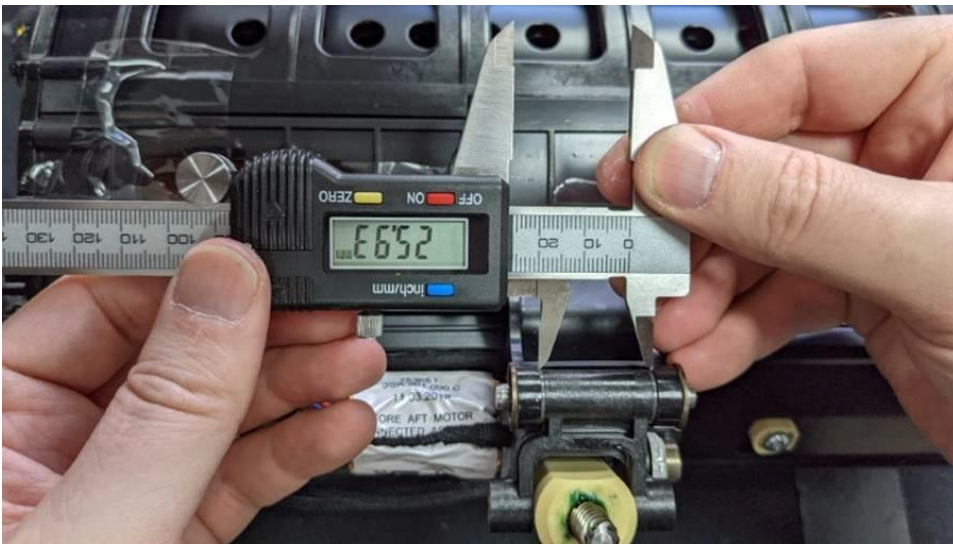
14) Referring to Figure 10 - Use a Vernier calliper to measure the dimension of the drive link support

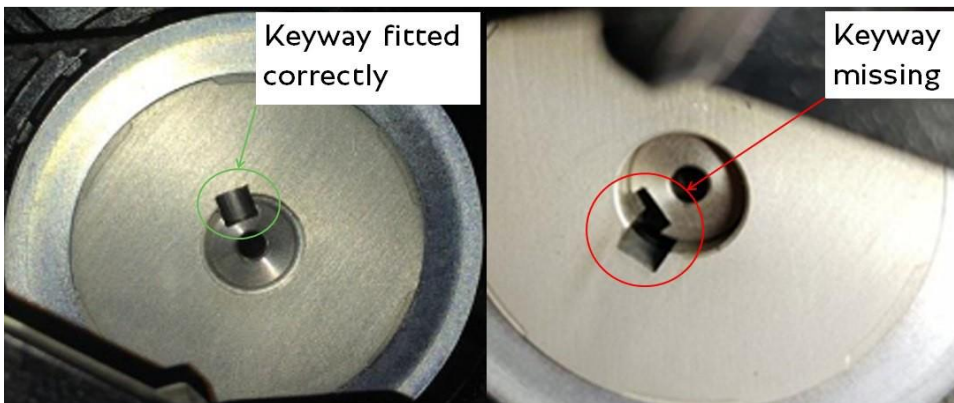
Figure 11

C. Grinding noise on operation

1. Remove rotating display then check pulley wheel for looseness and ensure keyway is present and fitted correctly (Figure 11).

If either defect is present raise a DISS technical query with photos attached.
