Technical product information

Topic	Rotating Display - Fault Diagnosis
Market area	Bentley: worldwide (2WBE),Hongkong-Macau (5HK)
Brand	Bentley
Transaction No.	2055580/9
Level	EH
Status	Approval
Release date

New Continental GT

New Flying Spur

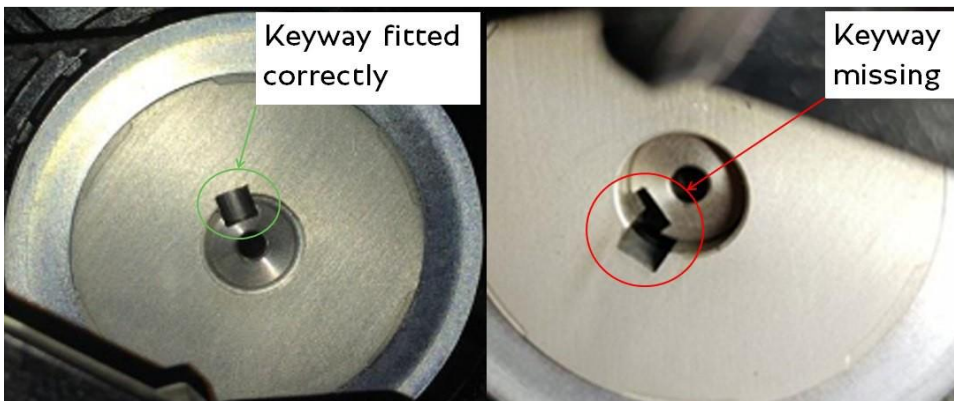
Figure 1

Check pulley wheel for looseness and ensure the keyway is present and fitted correctly (Figure 1)

If either defect is present raise a DISS technical query with photos attached, do not follow any more steps at this point

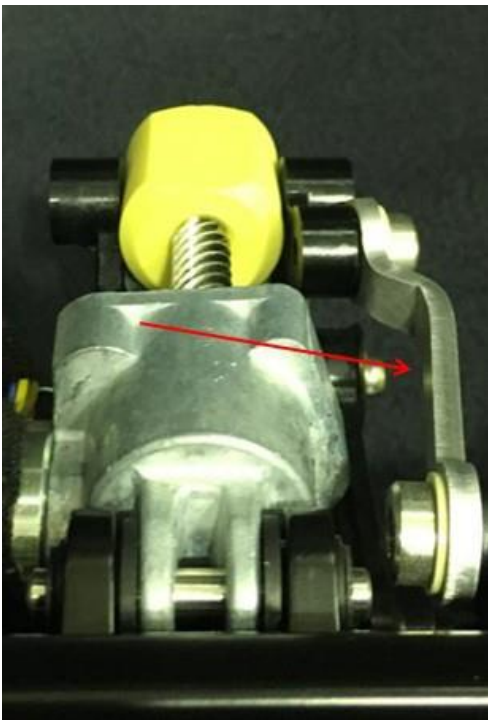
Figure 2

Check link bar for deformation (Figure 2)

If the link bar is deformed or bent, remove the link bar and attempt to straighten, then refit the link bar. Refit the rotating display to a state that it can be tested then carry out re-initialisation and retest. Should this not be successful raise a DISS technical query with photos attached, do not follow any more steps at this point.

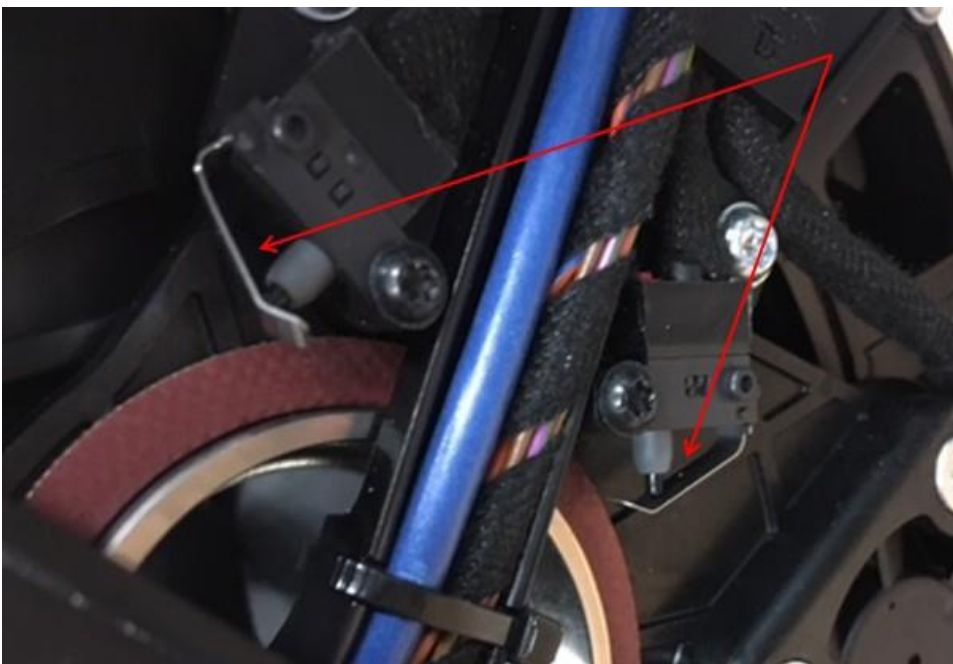
Figure 3

Check the condition of both micro switches for damage or connection misalignment (Figure 3)

If the micro switches are damaged or misaligned, attempt to repair and retest. Refit the rotating display to a state that it can be tested then carry out re-initialisation and retest. Should this not be successful raise a DISS technical query with photos attached, do not follow any more steps at this point.

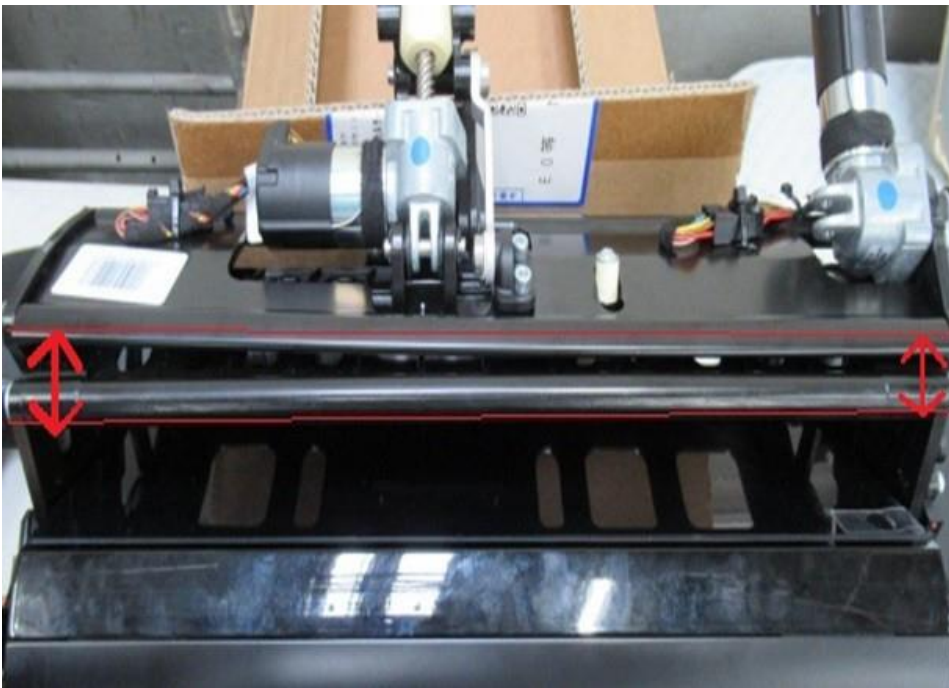
Figure 4

Check the alignment of inner to outer mechanism as shown (Figure 4)

If the mechanism is out of alignment raise a DISS technical query with photos attached, do not follow any more steps at this point.

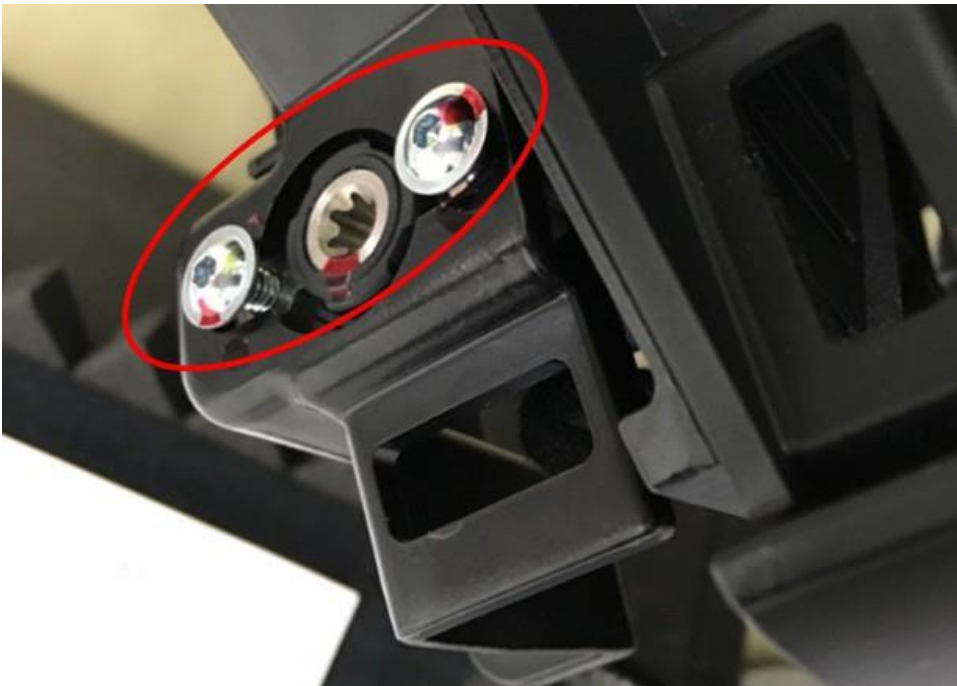
Figure 5

Check the tightness of the fixing screws highlighted (Figure 5), there are 8 fixing screws in total.

Check and retighten where necessary (3 Nm).

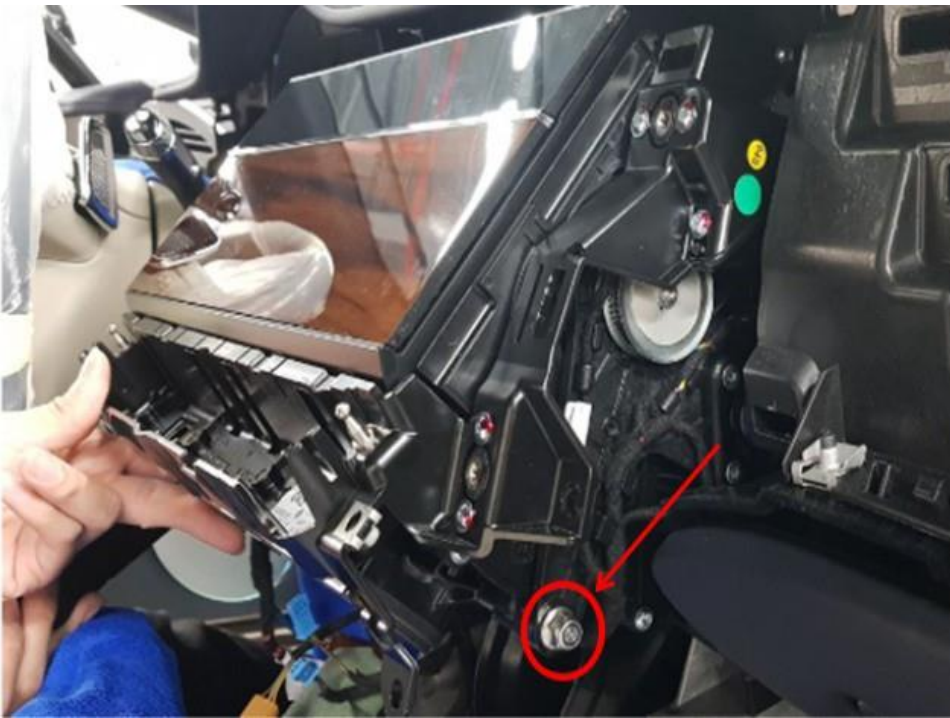
Figure 6

Check the tightness of the fixing nut highlighted (Figure 6), there is one nut on each side of the assembly.

Check and retighten where necessary (5 Nm).

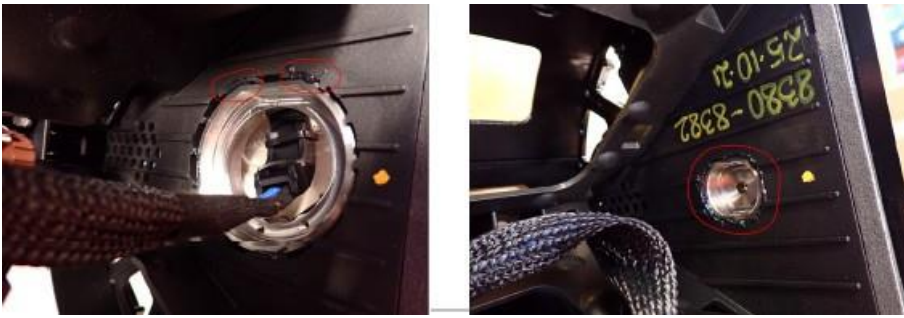
Figure 9

13) Check for bonding/adhesive of BRD bearings and capture images to confirm (Figure 9)

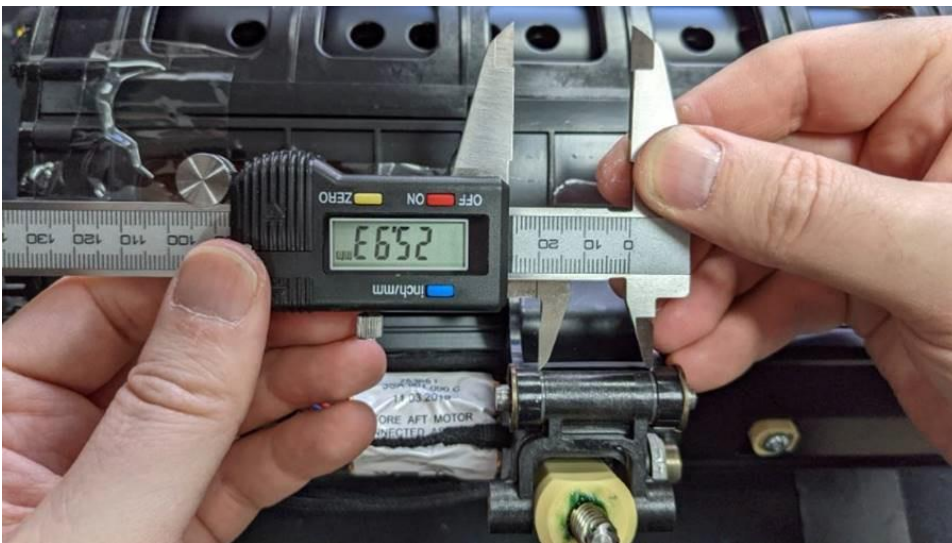
14) Referring to Figure 10 - Use a Vernier calliper to measure the dimension of the drive link support

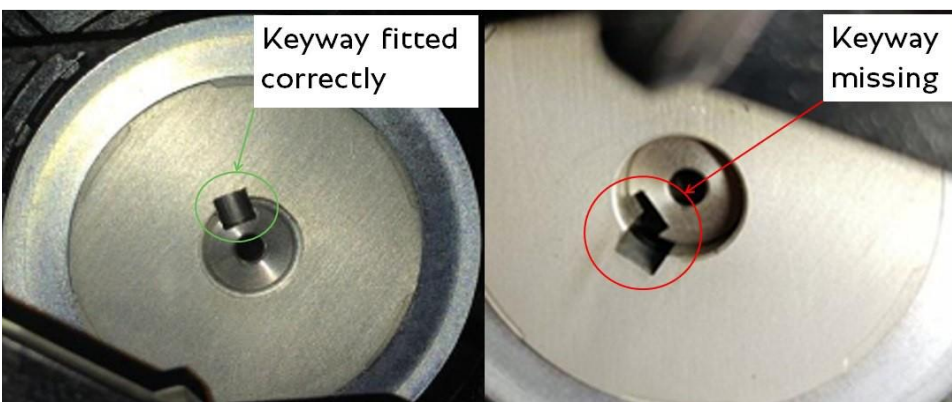
Figure 11

1. Remove rotating display then check pulley wheel for looseness and ensure keyway is present and fitted correctly (Figure 11).

If either defect is present raise a DISS technical query with photos attached.

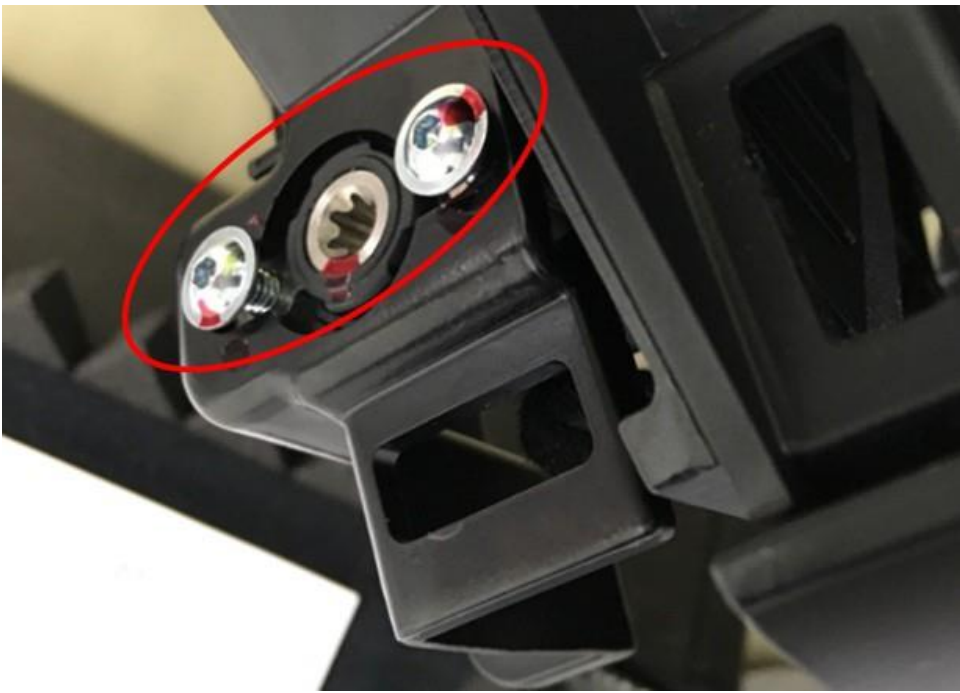
Figure 12

1. Remove rotating display then check and if necessary tighten fixing screws highlighted (Figure 12), there are 8 fixing screws in total. Check and retighten where necessary (3Nm).

2. Refit the rotating display to a state that it can be tested then carry out re-initialisation and retest.

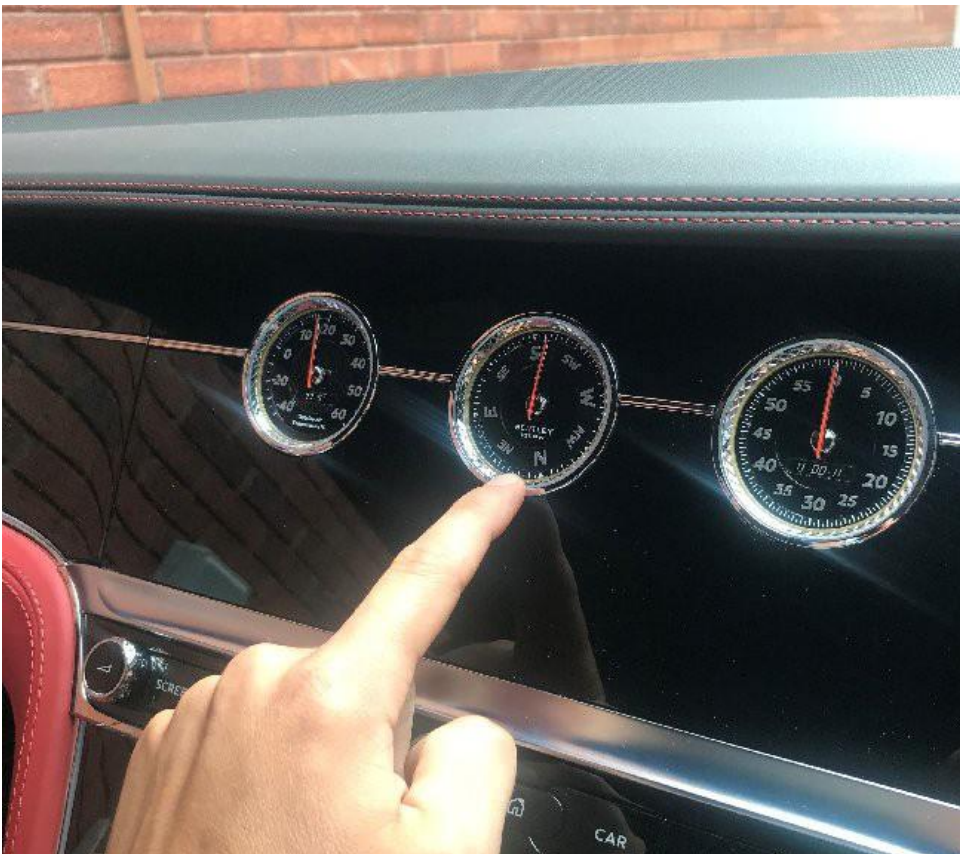
Figure 13

When noise is evident, press on outer bezels (Figure 13). If the noise disappears when the bezels of the dials are pressed then replace the dials.

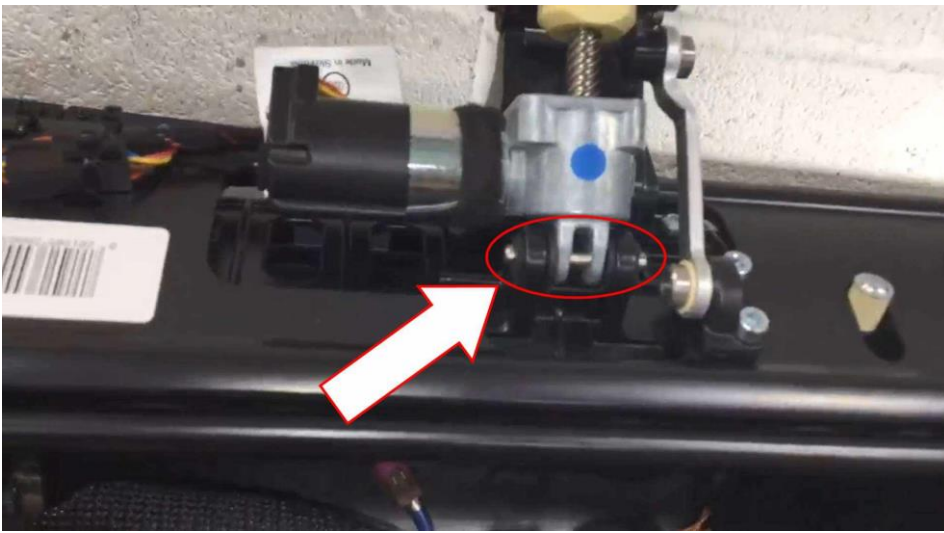
Figure 14

TIP: This symptom can in some cases be evident due to excessive movement within the rotating display motor pivot assembly (Figure 14)

- Refer to the Bentley Hub and refer to the video referencing TPI 2055580/-
- Should the movement be as shown in the video, the rotating display unit should be replaced
