Countries: CANADA, UNITED STATES, MEXICO Document ID: IK0700115
 Availability: ISIS, Bus ISIS, FleetISIS, IsSIR Revision: 14
 Major System: EXHAUST Created: 8/26/2021
 Current Language: English Last Modified: 11/18/2021
 Other Languages: [Français](#) Author: William Knoth
 Viewed: 8502

Title: QLS Emergency Calibration

Applies To: 2016 and Newer B6.7, X15 and L9, and all A26

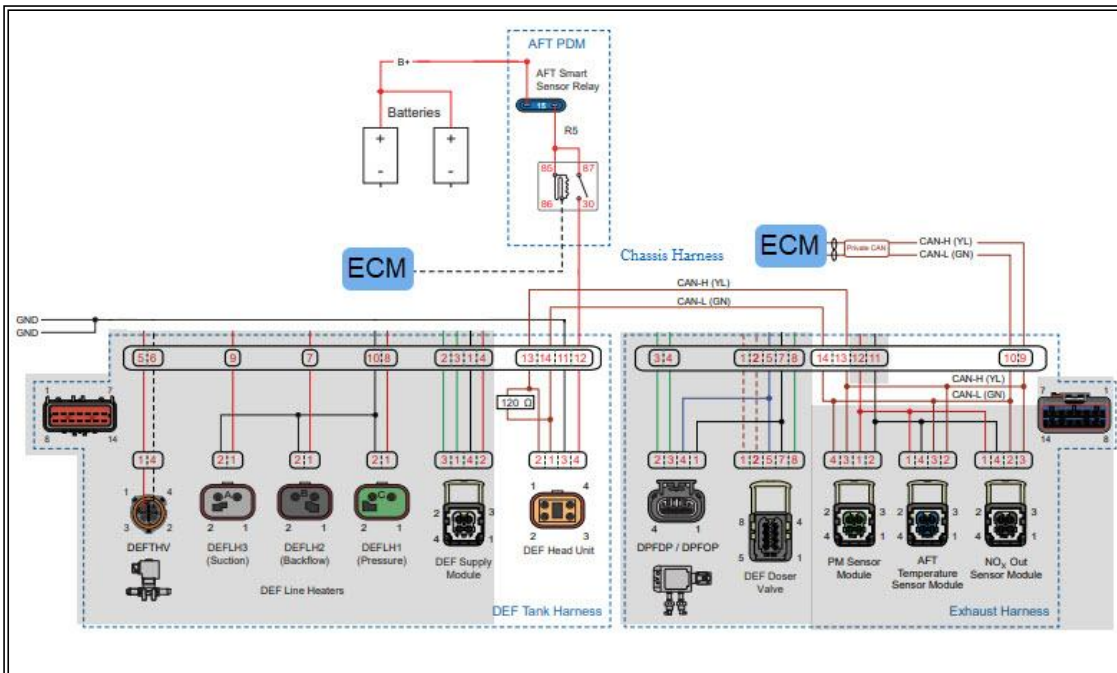
Figure 4: General QLS Wiring Diagram

Note: Refer to chassis circuit diagrams for detailed information

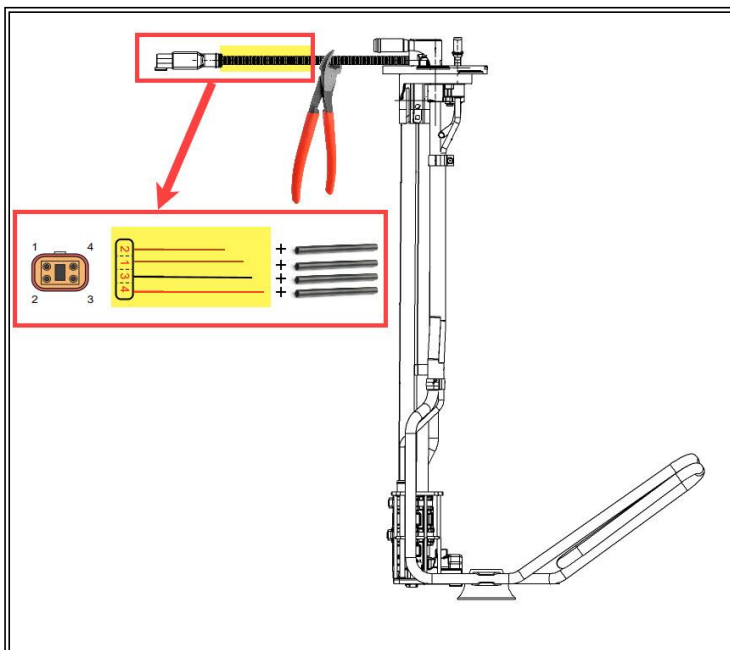
Figure 5: QLS Pigtail Modification

Item 1: QLS Pigtail

1. Ensure the QLS is disconnected from the chassis harness. **If the sensor is still connected it could result in shorting of the power circuit.**
2. Using wire cutters, cut the QLS pigtail harness as least four inches from the connector (Refer to figure #5). Once cut the pigtail can be moved to a bench for ease of installation.

Note: At no point is the QLS removed from the DEF tank during this procedure.
