SERVICE BULLETIN

Classification: BT21-020	Reference: NTB21-097	Date: October 20, 2021
-----------------------------	-------------------------	---------------------------

WATER LEAK AT TOP FRONT CORNERS OF WINDSHIELD

APPLIED VEHICLES: 2021 Rogue (T33)
APPLIED GRADES: All with either roof rails or roof side moldings

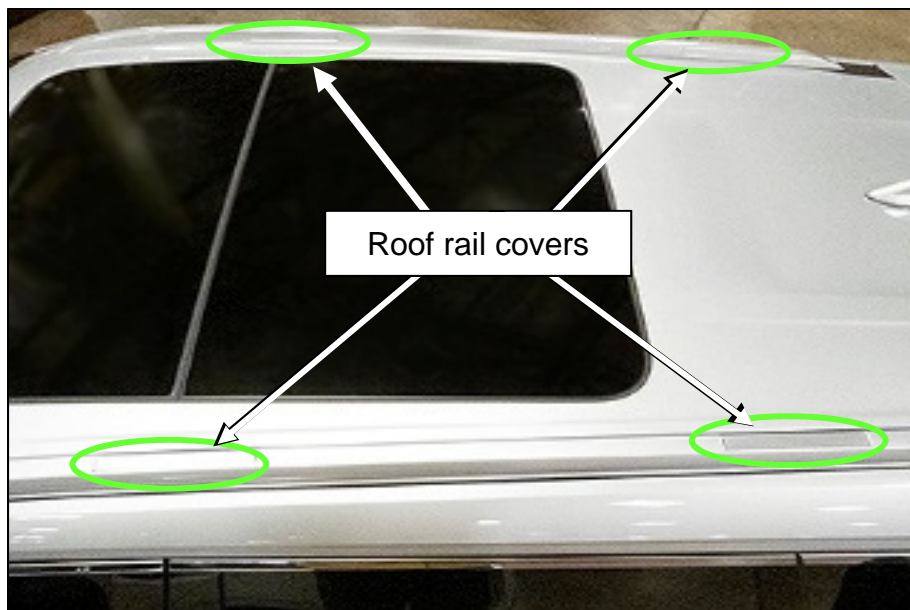
Figure 1

HINT: Vehicles that do not have cross bars will have roof rail covers over the bolts that are intended to hold the cross bars, as shown in Figure 1, Figure 2 and removed in Figure 3.

1. For "S" and "SV" grade vehicles that are equipped with roof side moldings (lay flat and do not have cross bar mounting bolts), skip to step 3.
2. Access the cross bar (roof rack) mounting bolts.
 - If cross bars are mounted, remove all eight (8) cross bar mounting bolts on the LH and RH sides of the vehicle, and then remove both cross bars from the vehicle.
 - If cross bars are not mounted, as shown in Figure 1, remove the four (4) roof rail covers and then all eight (8) bolts.
