CAMPAIGN BULLETIN

Running Boards Torque Dealer Inventory

Reference: PC851

PC851 - 2022 PATHFINDER RUNNING BOARD TORQUE

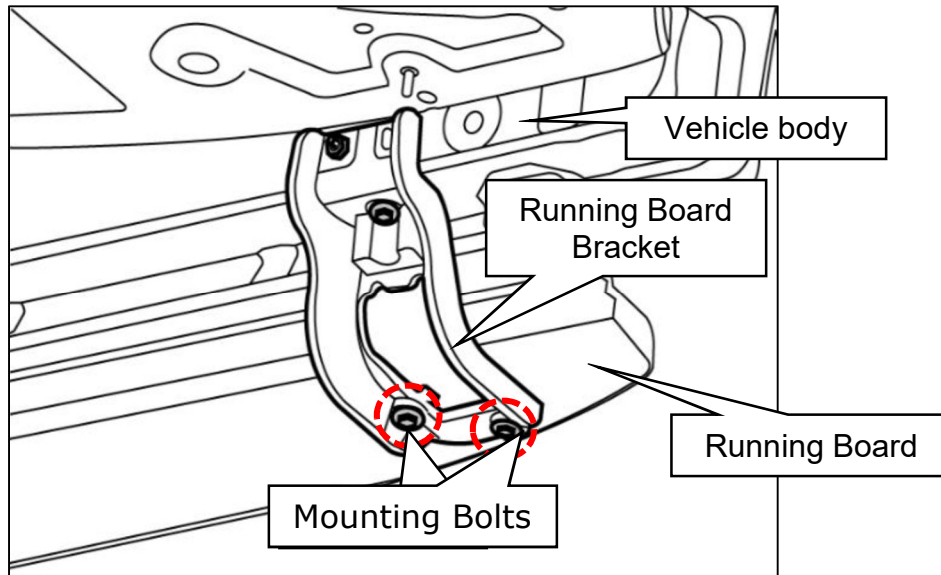
Figure 1

Nissan is conducting a dealer inventory quality action to torque the bolts on the running boards to correct specification on **38** specific MY2022 Nissan Pathfinder vehicles identified in Service Comm and National Service History – Open Campaigns. The subject bolts were not torqued to specification during installation.

1. Locate the running board mounting bolts. (Figure 1)

2. Torque the Running board mounting bolts on both sides of the vehicle.

- Using a T40 torx head socket, torque the 12 running board to bracket mounting bolts (3 brackets on each side of the vehicle, 2 bolts on each bracket)
- Torque to 24 N•m (2.4 kg-m, 18 ft-lbs).
