December 3, 2021

Product Improvement Campaign: 3G TCU VoLTE OTA Update

AFFECTED VEHICLES

Year	Model	Trim	VIN Range
2019–21	RDX	ALL	ALL

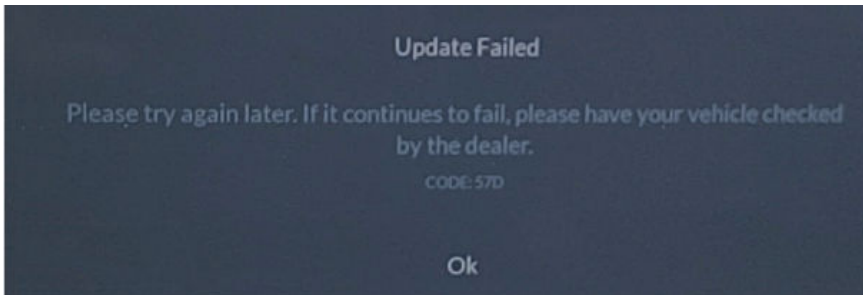
- If you see CODE: 57D or CODE: 5AC, the **Update Failed** due to **Poor cellular signal**.

- Move the vehicle to an open-air area to get **Optimal Cellular Signal** strength.

- Go back to step 1 to start the process once again
