GROUP	NUMBER	
Engine	21-EM-010H-1	
DATE	MODEL(S) Sonata (DN8a)	
NOVEMBER 2021

DN8A 1.6L TGDI MISFIRE
HIGH PRESSURE INJECTOR REPLACEMENT

This TSB supersedes TSB# 21-EM-010H to include updated parts information and service procedures to complete the repair.

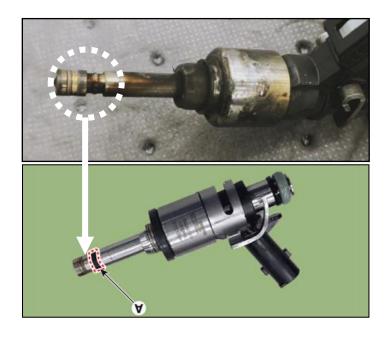
Description: Certain 2020-2021 Sonata (DN8a) vehicles with 1.6T engines may exhibit a check engine light in conjunction with a popping noise, abnormal smell from the engine compartment, rough running, or reduced power due to a misfire.

Follow the inspection procedure outlined in this bulletin to identify any high-pressure injectors with burnt injector tip seals and replace any affected injector and tip seals to repair the condition.
